DEMOLITION SURVEY
DENTON SWIMMING POOL
VICTORIA STREET
DENTON
MANCHESTER

Report prepared for:	AA Woods Holding Ltd Alma Street St Helens WA9 3AR
Report reference:	J180264
Issue date:	March 2020
Survey completed by: Karl Koffman Senior Surveyor

A Demolition Survey of Denton Swimming Pool, Victoria Street, Denton, Manchester, , M34 3GU, has been undertaken by AEC.

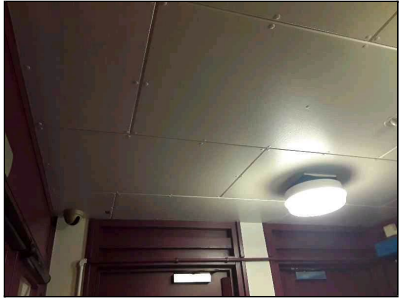
Item No:	000001	Laboratory sample no:	FB004012	
Accessibility:		Moderate		
Installation:		Boarding (2)		
Approx extent (m ² unless stated)		6		
Asbestos Type:		Amosite (2)		
Condition:		Low damage (1)	Surface Treatment: Surface sealed (1)

Material Risk Assessment	6	Priority Risk Assessment (PA)	N/A	Total Risk	N/A
Recommendation:	Remove				
Comments: NOTE - not all architrave prised back as some runs behind the sampled ceiling and it would not be safe to do so. Timber beading around window to office only accessed behind via existing holes so as not to smash the glass.

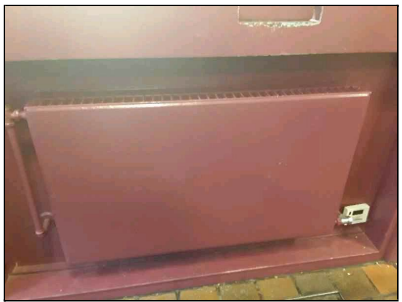
Item No:	000002	Laboratory sample no:	FB004013	
Accessibility:		Easy		
Installation:		Boarding (2)		
Approx extent (m ² unless stated)		1		
Asbestos Type:		Chrysotile + Amosite (2)		
Condition:		Low damage (1)	Surface Treatment: Surface sealed (1)

Material Risk Assessment	6	Priority Risk Assessment (PA)	N/A	Total Risk	N/A
Recommendation:	Remove				
Comments:

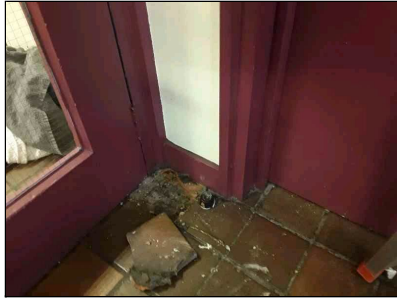
Item No:	000003	Laboratory sample no:	FB004014	
Accessibility:		N/A		
Installation:		Felt		
Approx extent (m ² unless stated)		N/A		
Asbestos Type:		NAD		
Condition:		N/A	Surface Treatment:	N/A

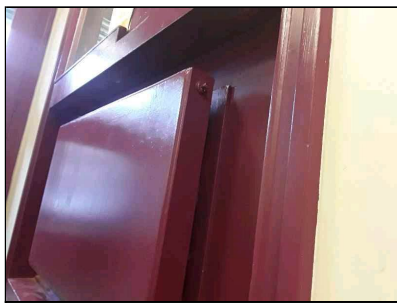
Item No:	000004	Laboratory sample no:	SP FB004013	
Accessibility:		Easy		
Installation:		Boarding (2)		
Approx extent (m ² unless stated)		1		
Asbestos Type:		Chrysotile + Amosite (2)		
Condition:		Low damage (1)	Surface Treatment:	Surface sealed (1)

Material Risk Assessment	6	Priority Risk Assessment (PA)	N/A	Total Risk	N/A
Recommendation:	Remove				
Comments:

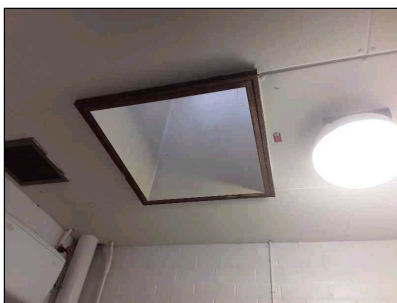
Item No:	000005	Laboratory sample no:	SP FB004012	
Accessibility:		Moderate		
Installation:		Boarding (2)		
Approx extent (m ² unless stated)		8		
Asbestos Type:		Amosite (2)		
Condition:		Low damage (1)	Surface Treatment: Surface sealed (1)

Material Risk Assessment	6	Priority Risk Assessment (PA)	N/A	Total Risk	N/A
Recommendation:		Remove			
Comments: NOTE - no access behind timber panels of skylight as it is partially attached to the sampled ceiling. NOTE - not all architrave prised back as some runs behind the sampled ceiling and it would be not safe to do so.

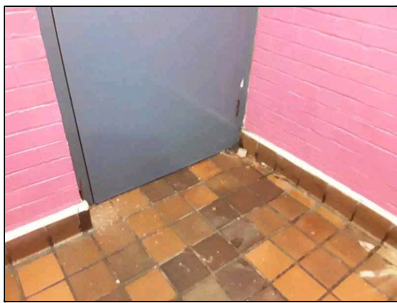
Item No:	000006	Laboratory sample no:	SP FB004014	
Accessibility:		N/A		
Installation:		Felt		
Approx extent (m ² unless stated)		N/A		
Asbestos Type:		NAD		
Condition:		N/A	Surface Treatment: N/A

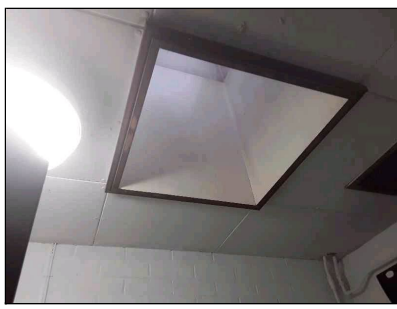
Item No:	000007	Laboratory sample no:	SP FB004012	
Accessibility:		Moderate		
Installation:		Boarding (2)		
Approx extent (m ² unless stated)		8		
Asbestos Type:		Amosite (2)		
Condition:		Low damage (1)	Surface Treatment: Surface sealed (1)

Material Risk Assessment	6	Priority Risk Assessment (PA)	N/A	Total Risk	N/A
Recommendation:	Remove				
Comments: NOTE - no access behind timber panels of skylight as it is partially attached to the sampled ceiling. NOTE - not all architrave prised back as some runs behind the sampled ceiling and it would be not safe to do so.

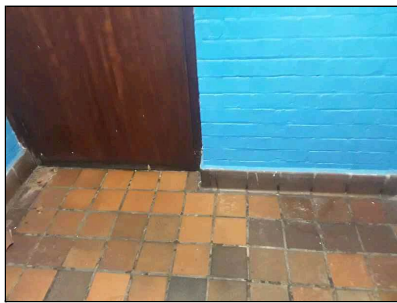
Item No:	000008	Laboratory sample no:	SP FB004014	
Accessibility:		N/A		
Installation:		Felt		
Approx extent (m ² unless stated)		N/A		
Asbestos Type:		NAD		
Condition:		N/A	Surface Treatment: N/A

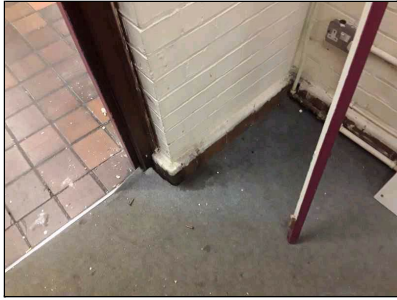
Item No:	000009	Laboratory sample no:	SP FB004014	
Accessibility:	N/A			
Installation:	Felt			
Approx extent (m ² unless stated)	N/A			
Asbestos Type:	NAD			
Condition:	N/A	Surface Treatment:	N/A

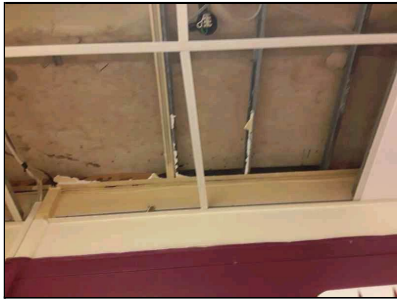
Item No:	000010	Laboratory sample no:	FB004015	
Accessibility:	N/A			
Installation:	Boarding			
Approx extent (m ² unless stated)	N/A			
Asbestos Type:	NAD			
Condition:	N/A	Surface Treatment:	N/A

Material Risk Assessment	0	Priority Risk Assessment (PA)	N/A	Total Risk	
Recommendation:	None				
Comments:	Negative sampling - polystyrene

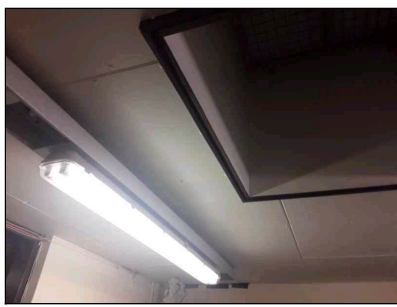
Item No:	000011	Laboratory sample no:	FB004016	
Accessibility:		Moderate		
Installation:		Boarding (2)		
Approx extent (m ² unless stated)		15		
Asbestos Type:		Chrysotile + Amosite (2)		
Condition:		Low damage (1)	Surface Treatment:	Surface sealed (1)

Material Risk Assessment	6	Priority Risk Assessment (PA)	N/A	Total Risk	N/A
Recommendation:		Remove			
Comments: No access behind adjoining skylight

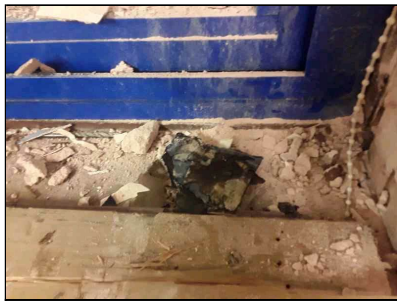
Item No:	000012	Laboratory sample no:	FB004017	
Accessibility:		N/A		
Installation:		Felt		
Approx extent (m ² unless stated)		N/A		
Asbestos Type:		NAD		
Condition:		N/A	Surface Treatment:	N/A

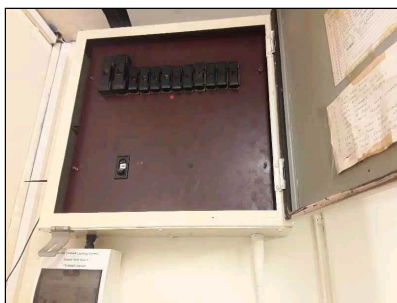
Item No:	000015	Laboratory sample no:	Not sampled	
Accessibility:	No access gained			
Installation:	Unknown (3)			
Approx extent (m ² unless stated)	Unknown			
Asbestos Type:	Presumed asbestos (3)			
Condition:	High damage (3)	Surface Treatment:	Unsealed (3)

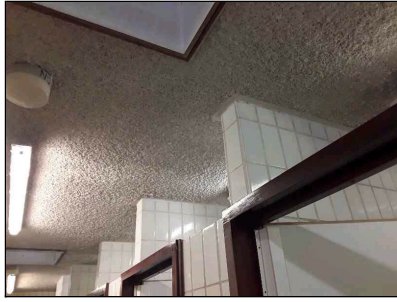
Item No:	000017	Laboratory sample no:	FB004019	
Accessibility:		N/A		
Installation:		Sprayed coating		
Approx extent (m ² unless stated)		N/A		
Asbestos Type:		NAD		
Condition:		N/A	Surface Treatment:	N/A

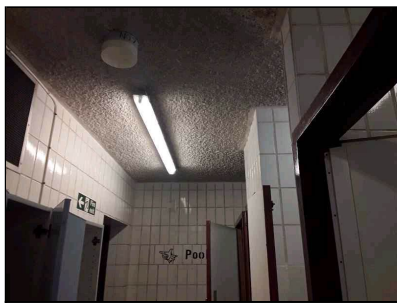
Item No:	000018	Laboratory sample no:	FB004020	
Accessibility:		N/A		
Installation:		Sprayed coating		
Approx extent (m ² unless stated)		N/A		
Asbestos Type:		NAD		
Condition:		N/A	Surface Treatment:	N/A

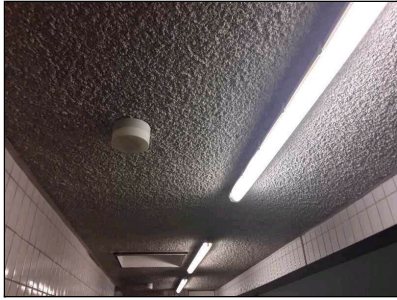
Item No:	000021	Laboratory sample no:	FB004022	
Accessibility:		N/A		
Installation:		Sprayed coating		
Approx extent (m ² unless stated)		N/A		
Asbestos Type:		NAD		
Condition:		N/A	Surface Treatment:

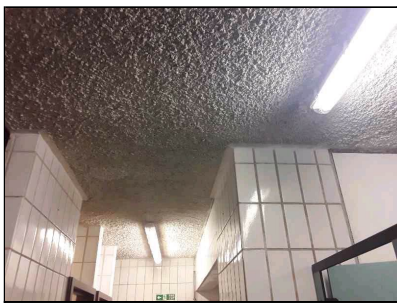
Item No:	000022	Laboratory sample no:	FB004023	
Accessibility:		N/A		
Installation:		Sprayed coating		
Approx extent (m ² unless stated)		N/A		
Asbestos Type:		NAD		
Condition:		N/A	Surface Treatment:

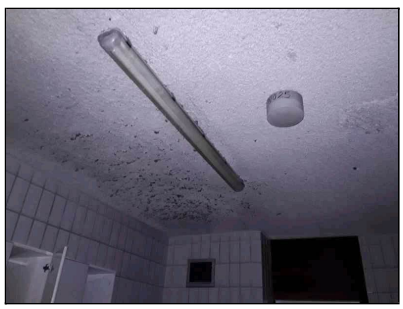
Item No:	000027	Laboratory sample no:	FB004025	
Accessibility:	N/A			
Installation:	Insulation			
Approx extent (m ² unless stated)	N/A			
Asbestos Type:	NAD			
Condition:	N/A	Surface Treatment:	N/A

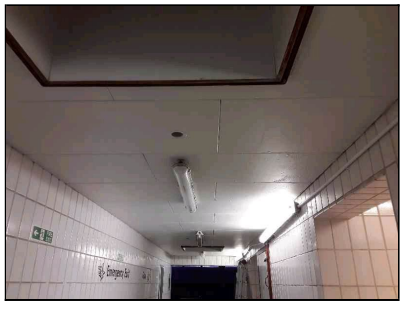
Item No:	000028	Laboratory sample no:	FB004026	
Accessibility:	Moderate			
Installation:	Boarding (2)			
Approx extent (m ² unless stated)	30			
Asbestos Type:	Chrysotile + Amosite (2)			
Condition:	Low damage (1)	Surface Treatment:	Surface sealed (1)

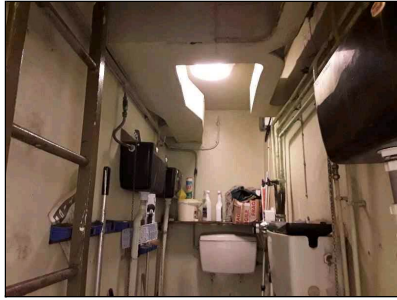
Item No:	000029	Laboratory sample no:	Not sampled	
Accessibility:		N/A		
Installation:		Unknown		
Approx extent (m ² unless stated)		N/A		
Asbestos Type:		NAD		
Condition:		N/A	Surface Treatment:

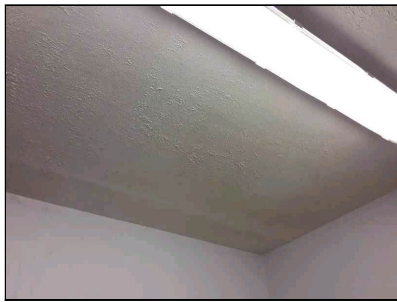
Item No:	000030	Laboratory sample no:	FB004027	
Accessibility:		N/A		
Installation:		Textured coating		
Approx extent (m ² unless stated)		N/A		
Asbestos Type:		NAD		
Condition:		N/A	Surface Treatment:

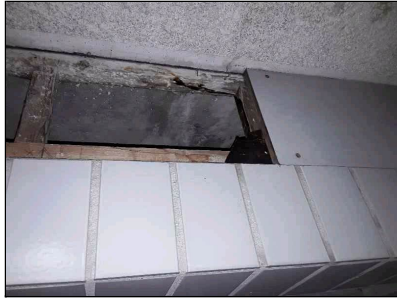
Item No:	000033	Laboratory sample no:	FB004030	
Accessibility:	N/A			
Installation:	Felt			
Approx extent (m ² unless stated)	N/A			
Asbestos Type:	NAD			
Condition:	N/A	Surface Treatment:	N/A

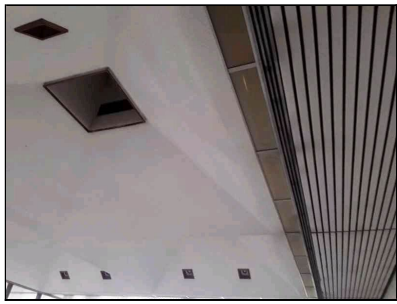
Item No:	000034	Laboratory sample no:	FB004031	
Accessibility:	Moderate			
Installation:	Sprayed coating (3)			
Approx extent (m ² unless stated)	>100			
Asbestos Type:	Chrysotile + Amosite (2)			
Condition:	Low damage (1)	Surface Treatment:	Unsealed AIB/encapsulated lagging (2)

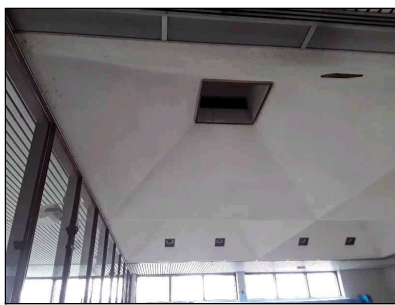
Item No:	000035	Laboratory sample no:	FB004032	
Accessibility:		Moderate		
Installation:		Sprayed coating (3)		
Approx extent (m ² unless stated)		>100		
Asbestos Type:		Chrysotile + Amosite (2)		
Condition:	Low damage (1)	Surface Treatment:	Unsealed AIB/encapsulated lagging (2)

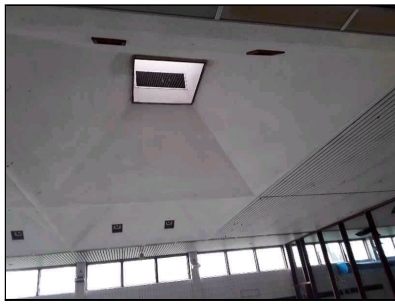
Item No:	000036	Laboratory sample no:	FB004033	
Accessibility:		Moderate		
Installation:		Sprayed coating (3)		
Approx extent (m ² unless stated)		>200		
Asbestos Type:		Chrysotile + Amosite (2)		
Condition:	Low damage (1)	Surface Treatment:	Unsealed AIB/encapsulated lagging (2)

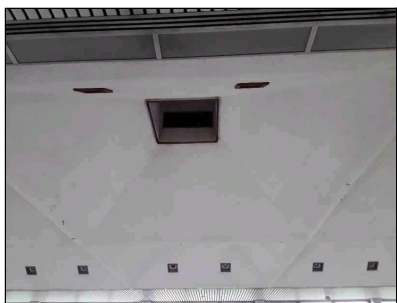
Item No:	000037	Laboratory sample no:	FB004034	
Accessibility:		Moderate		
Installation:		Sprayed coating (3)		
Approx extent (m ² unless stated)		>200		
Asbestos Type:		Chrysotile + Amosite (2)		
Condition:		Low damage (1)	Surface Treatment: Unsealed AIB/encapsulated lagging (2)

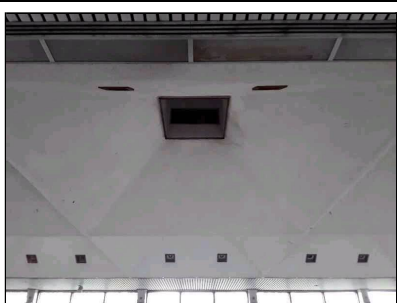
Item No:	000038	Laboratory sample no:	FB004035	
Accessibility:		Moderate		
Installation:		Sprayed coating (3)		
Approx extent (m ² unless stated)		>200		
Asbestos Type:		Chrysotile + Amosite (2)		
Condition:		Low damage (1)	Surface Treatment: Unsealed AIB/encapsulated lagging (2)

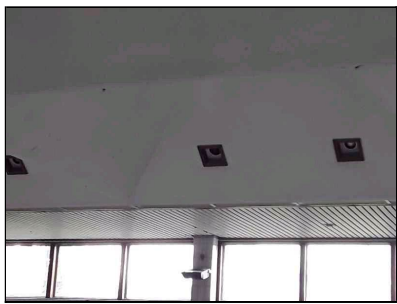
Item No:	000040	Laboratory sample no:	FB004037	
Accessibility:		Moderate		
Installation:		Sprayed coating (3)		
Approx extent (m ² unless stated)		>200		
Asbestos Type:		Chrysotile + Amosite (2)		
Condition:		Low damage (1)	Surface Treatment:	Unsealed AIB/encapsulated lagging (2)

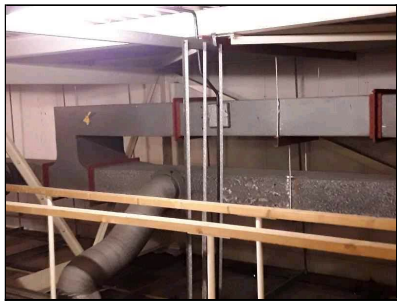
Item No:	000042	Laboratory sample no:	FB004039	
Accessibility:	Moderate			
Installation:	Boarding (2)			
Approx extent (m ² unless stated)	>300			
Asbestos Type:	Amosite (2)			
Condition:	Low damage (1)	Surface Treatment:	Unsealed AIB/encapsulated lagging (2)

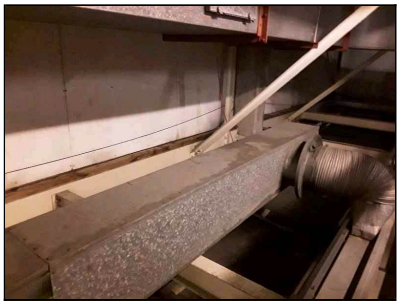
Item No:	000044	Laboratory sample no:	FB004041	
Accessibility:		Moderate		
Installation:		Boarding (2)		
Approx extent (m ² unless stated)		>300		
Asbestos Type:		Amosite (2)		
Condition:		Low damage (1)	Surface Treatment:	Unsealed AIB/encapsulated lagging (2)

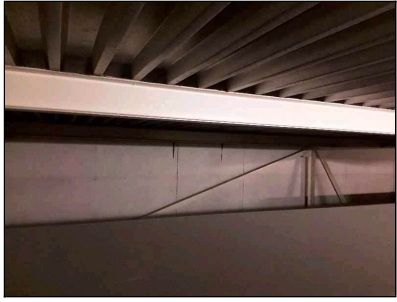
Item No:	000045	Laboratory sample no:	FB004042	
Accessibility:		Moderate		
Installation:		Boarding (2)		
Approx extent (m ² unless stated)		>300		
Asbestos Type:		Amosite (2)		
Condition:		Low damage (1)	Surface Treatment:	Unsealed AIB/encapsulated lagging (2)

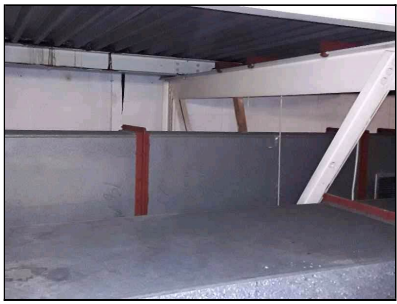
Item No:	000046	Laboratory sample no:	FB004043	
Accessibility:		Moderate		
Installation:		Boarding (2)		
Approx extent (m ² unless stated)		>300		
Asbestos Type:		Amosite (2)		
Condition:		Low damage (1)	Surface Treatment:	Unsealed AIB/encapsulated lagging (2)

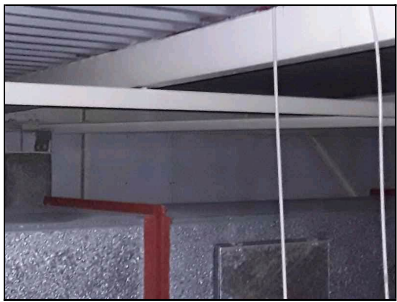
Item No:	000048	Laboratory sample no:	FB004045	
Accessibility:	Moderate			
Installation:	Boarding (2)			
Approx extent (m ² unless stated)	>300			
Asbestos Type:	Amosite (2)			
Condition:	Low damage (1)	Surface Treatment:	Unsealed AIB/encapsulated lagging (2)

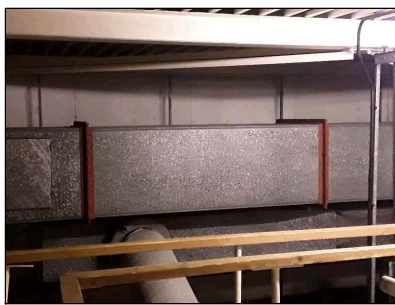
Item No:	000049	Laboratory sample no:	FB004046	
Accessibility:		Moderate		
Installation:		Boarding (2)		
Approx extent (m ² unless stated)		>300		
Asbestos Type:		Amosite (2)		
Condition:		Low damage (1)	Surface Treatment: Unsealed AIB/encapsulated lagging (2)

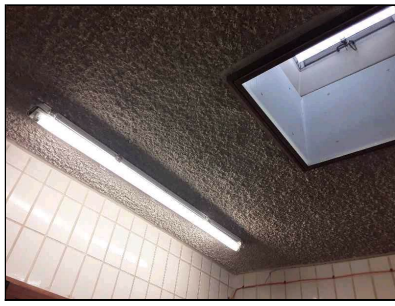
Item No:	000050	Laboratory sample no:	FB004047	
Accessibility:		N/A		
Installation:		Sprayed coating		
Approx extent (m ² unless stated)		N/A		
Asbestos Type:		NAD		
Condition:		N/A	Surface Treatment: N/A

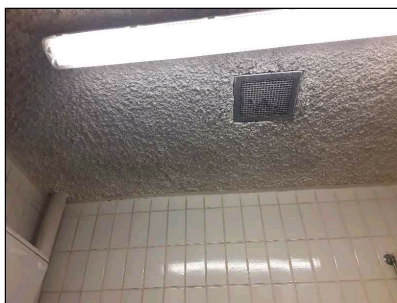
Item No:	000051	Laboratory sample no:	SP FB004047	
Accessibility:		N/A		
Installation:		Sprayed coating		
Approx extent (m ² unless stated)		N/A		
Asbestos Type:		NAD		
Condition:		N/A	Surface Treatment:

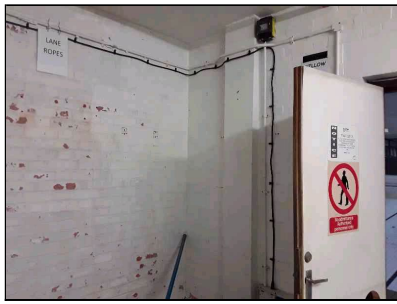
Item No:	000052	Laboratory sample no:	Not sampled	
Accessibility:		N/A		
Installation:		Unknown		
Approx extent (m ² unless stated)		N/A		
Asbestos Type:		NAD		
Condition:		N/A	Surface Treatment:

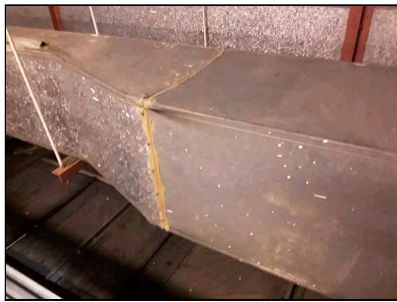
Item No:	000054	Laboratory sample no:	FB004049	
Accessibility:		N/A		
Installation:		Mastic		
Approx extent (m ² unless stated)		N/A		
Asbestos Type:		NAD		
Condition:		N/A	Surface Treatment: N/A

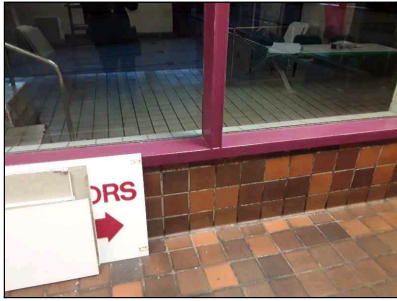
Item No:	000061	Laboratory sample no:	Not sampled	
Accessibility:	No access gained			
Installation:	Unknown (3)			
Approx extent (m ² unless stated)	Unknown			
Asbestos Type:	Presumed asbestos (3)			
Condition:	High damage (3)	Surface Treatment:	Unsealed (3)

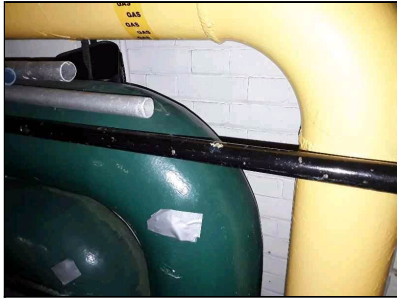
Item No:	000062	Laboratory sample no:	FB004055	
Accessibility:	N/A			
Installation:	Insulation			
Approx extent (m ² unless stated)	N/A			
Asbestos Type:	NAD			
Condition:	N/A	Surface Treatment:	N/A

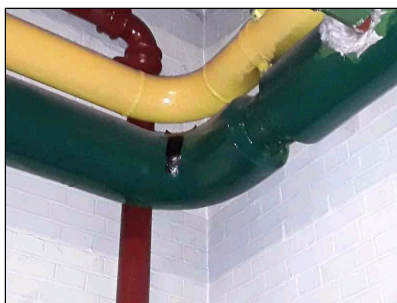
Item No:	000065	Laboratory sample no:	FB004058	
Accessibility:	N/A			
Installation:	Insulation			
Approx extent (m ² unless stated)	N/A			
Asbestos Type:	NAD			
Condition:	N/A	Surface Treatment:	N/A

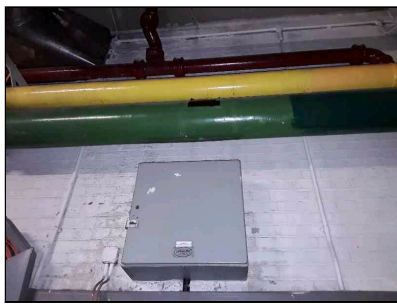
Item No:	000066	Laboratory sample no:	FB004059	
Accessibility:	N/A			
Installation:	Insulation			
Approx extent (m ² unless stated)	N/A			
Asbestos Type:	NAD			
Condition:	N/A	Surface Treatment:	N/A

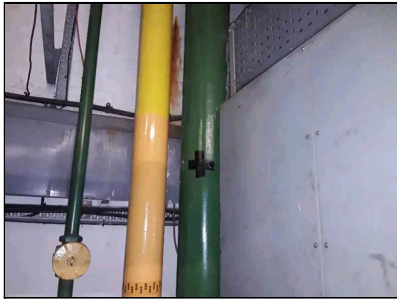
Item No:	000068	Laboratory sample no:	FB004061	
Accessibility:	N/A			
Installation:	Insulation			
Approx extent (m ² unless stated)	N/A			
Asbestos Type:	NAD			
Condition:	N/A	Surface Treatment:	N/A

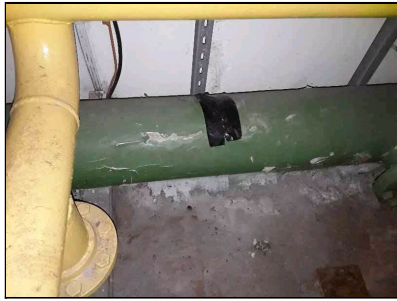
Item No:	000070	Laboratory sample no:	FB004063	
Accessibility:		N/A		
Installation:		Insulation		
Approx extent (m ² unless stated)		N/A		
Asbestos Type:		NAD		
Condition:		N/A	Surface Treatment:

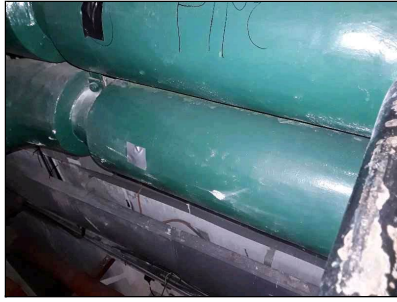
Item No:	000077	Laboratory sample no:	FB004070	
Accessibility:		N/A		
Installation:		Insulation		
Approx extent (m ² unless stated)		N/A		
Asbestos Type:		NAD		
Condition:		N/A	Surface Treatment:

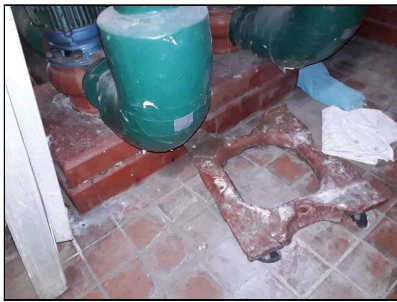
Item No:	000082	Laboratory sample no:	FB004075	
Accessibility:	N/A			
Installation:	Insulation			
Approx extent (m ² unless stated)	N/A			
Asbestos Type:	NAD			
Condition:	N/A	Surface Treatment:	N/A

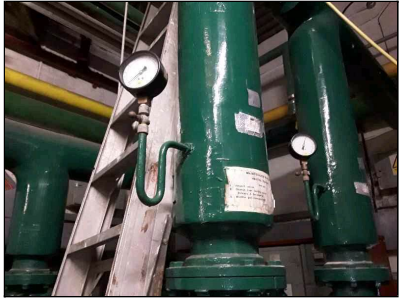
Item No:	000083	Laboratory sample no:	FB004076	
Accessibility:	N/A			
Installation:	Insulation			
Approx extent (m ² unless stated)	N/A			
Asbestos Type:	NAD			
Condition:	N/A	Surface Treatment:	N/A

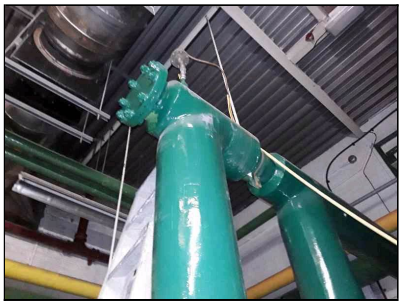
Item No:	000084	Laboratory sample no:	FB004077	
Accessibility:	N/A			
Installation:	Insulation			
Approx extent (m ² unless stated)	N/A			
Asbestos Type:	NAD			
Condition:	N/A	Surface Treatment:	N/A

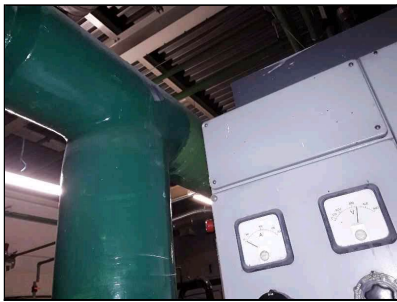
Item No:	000088	Laboratory sample no:	FB004081	
Accessibility:	N/A			
Installation:	Insulation			
Approx extent (m ² unless stated)	N/A			
Asbestos Type:	NAD			
Condition:	N/A	Surface Treatment:	N/A

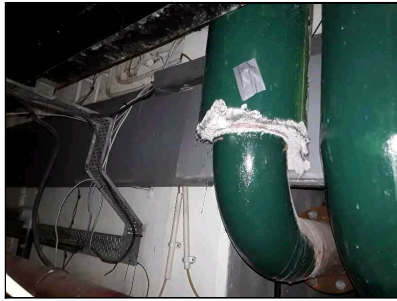
Item No:	000092	Laboratory sample no:	FB004085	
Accessibility:	N/A			
Installation:	Insulation			
Approx extent (m ² unless stated)	N/A			
Asbestos Type:	NAD			
Condition:	N/A	Surface Treatment:	N/A

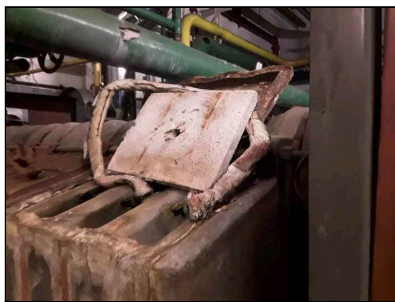
Item No:	000106	Laboratory sample no:	FB004099	
Accessibility:	N/A			
Installation:	Boarding			
Approx extent (m ² unless stated)	N/A			
Asbestos Type:	NAD			
Condition:	N/A	Surface Treatment:	N/A

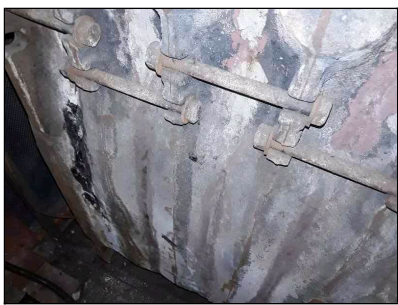
Item No:	000107	Laboratory sample no:	FB004100	
Accessibility:		N/A		
Installation:		Mastic		
Approx extent (m ² unless stated)		N/A		
Asbestos Type:		NAD		
Condition:		N/A	Surface Treatment:

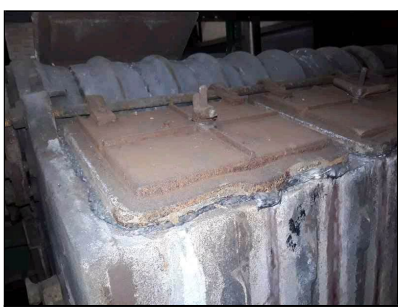
Item No:	000108	Laboratory sample no:	FB004101	
Accessibility:		N/A		
Installation:		Rope		
Approx extent (m ² unless stated)		N/A		
Asbestos Type:		NAD		
Condition:		N/A	Surface Treatment:

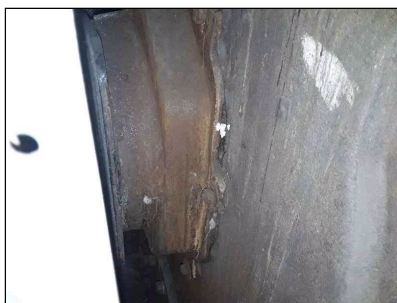
Item No:	000113	Laboratory sample no:	FB004106	
Accessibility:		Easy		
Installation:		Rope (2)		
Approx extent (m ² unless stated)		11m		
Asbestos Type:		Chrysotile (1)		
Condition:		Low damage (1)	Surface Treatment:	Surface sealed (1)
