RAIL CROSSING DIVERSION ORDER (SECTION 119A HIGHWAYS ACT 1980)

Name / number	Moss Lane Farm Crossing
Town	Ashton Under Lyne
Grid reference	SJ919993
Details of rail crossing	User works crossing with Public footpath ASH/108 scheduled over.

**Trans Pennine Electrification West
Level Crossing Risk Assessment
Moss Lane Farm level crossing**

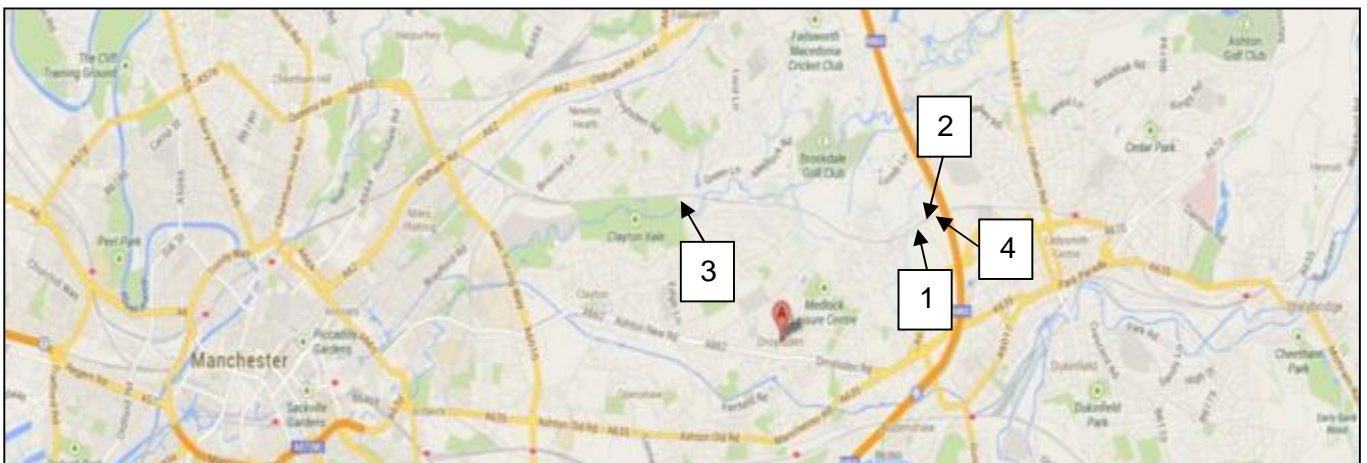
Figure 2: Geographic locations of level crossings between Manchester Victoria Station to Stalybridge Station

A summary of the crossings to be considered is shown in Table 1 and the geographical locations of the crossings are shown in Figure 2.

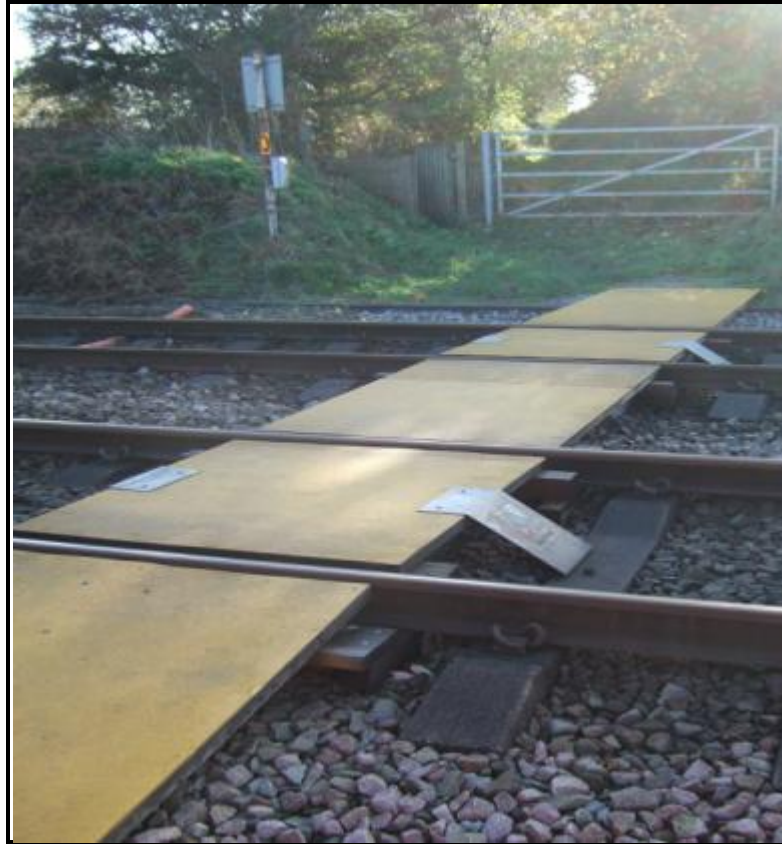
Figure 3: Moss Lane Farm level crossing looking south, November 2013

Moss Lane Farm level crossing is located east of Ashton-Under-Lyne and northeast of Droylsden, in Greater Manchester. The crossing type is User Worked and there are telephones installed on both sides of the crossing. Considering the potential for vehicle use over the crossing it was noted during a site visit in November 2013 that on the north side of the crossing is no gate which could be used to allow a vehicle onto the crossing and the width of the crossing surface could not accommodate a vehicle.

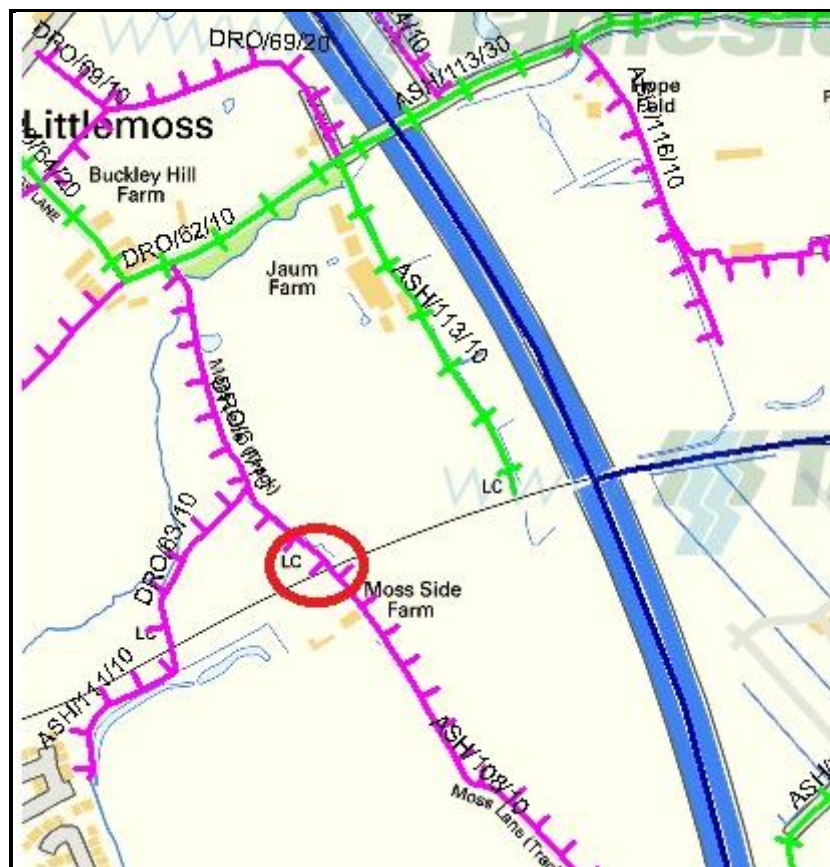
Figure 4: Extract from Tameside Metropolitan Borough Council website. A red circle highlights the public footpath across Moss Lane Farm level crossing, November 2013

The Tameside Metropolitan Borough Council website, advises current public rights of way and the map extract shown in Figure 4 shows the footpath over Moss Lane Farm level crossing.

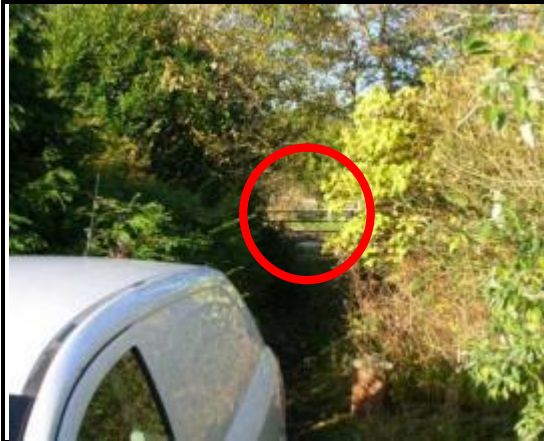
Figure 9: Moss Lane travelling towards Moss Lane Farm level crossing. The red circle highlights the gate at the crossing. The vehicle on the bottom left corner is the closest position a vehicle could get to the crossing.
November 2013

The approach to Moss Lane Farm level crossing from the south is along Moss Lane and Rayner Lane which are un-surfaced public carriageways from the A6410 carriageway, also known as Lord Sheldon Way. The un-surfaced carriageway leads onto an un-surfaced footpath, as shown in Figure 10, which continues towards the railway, bordered by established vegetation, as shown in Figure 10. The footpath descends with a very small gradient until it meets the railway boundary gate, where the footpath gradient changes to be flat, as shown in Figure 11. The footpath passes over the railway in a south to north direction.

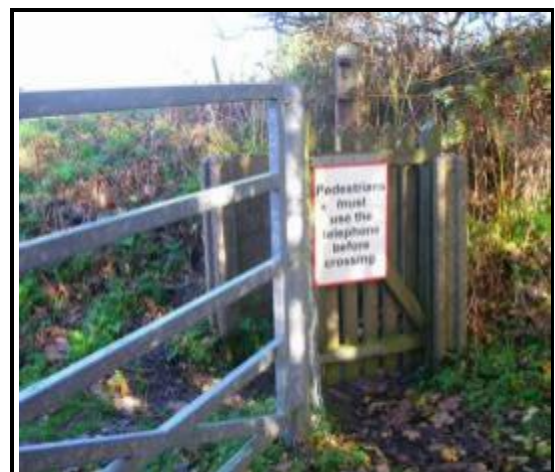
Figure 12: View of wicket gate with sign advising pedestrians to use the telephone before crossing.
November 2013

There are existing telephones installed on both sides of the crossing which connect to the controlling signal boxes. There is a sign located on the pedestrian gate to the south of the crossing which advises people to use the telephone to contact the controlling signal box, as shown in Figure 12. It is noted that there is no sign on the gate when approaching the crossing from the north. The findings of the 9 day survey of the crossing advised only 10% of people passing over the crossing used the telephones, for the duration of the survey.

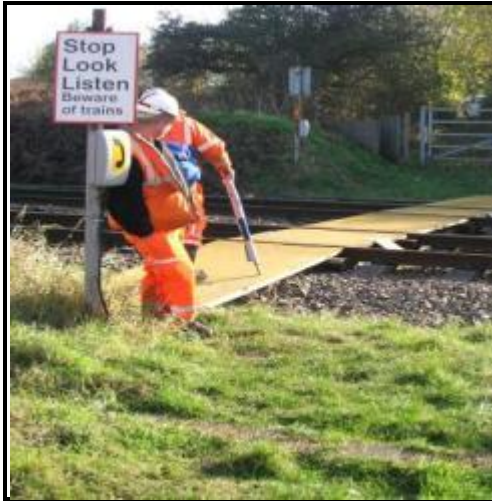
Figure 17: Ground condition approaching Moss Lane Farm level crossing from the north. November 2013

The immediate approach to the crossing from the south is flat and un-surfaced, as can be seen in Figures 17 and 18. Approaching from the north the footpath is un-surfaced and un-defined, as shown in Figure 17. There is also a troughing route which passes across the path from the gate to the crossing surface. There are Stop Look Listen signs and telephones located on both sides of the crossing, as shown in the Figures 19 and 20.

The surface of the crossing appeared to be in good condition, as shown in Figures 17 & 18.

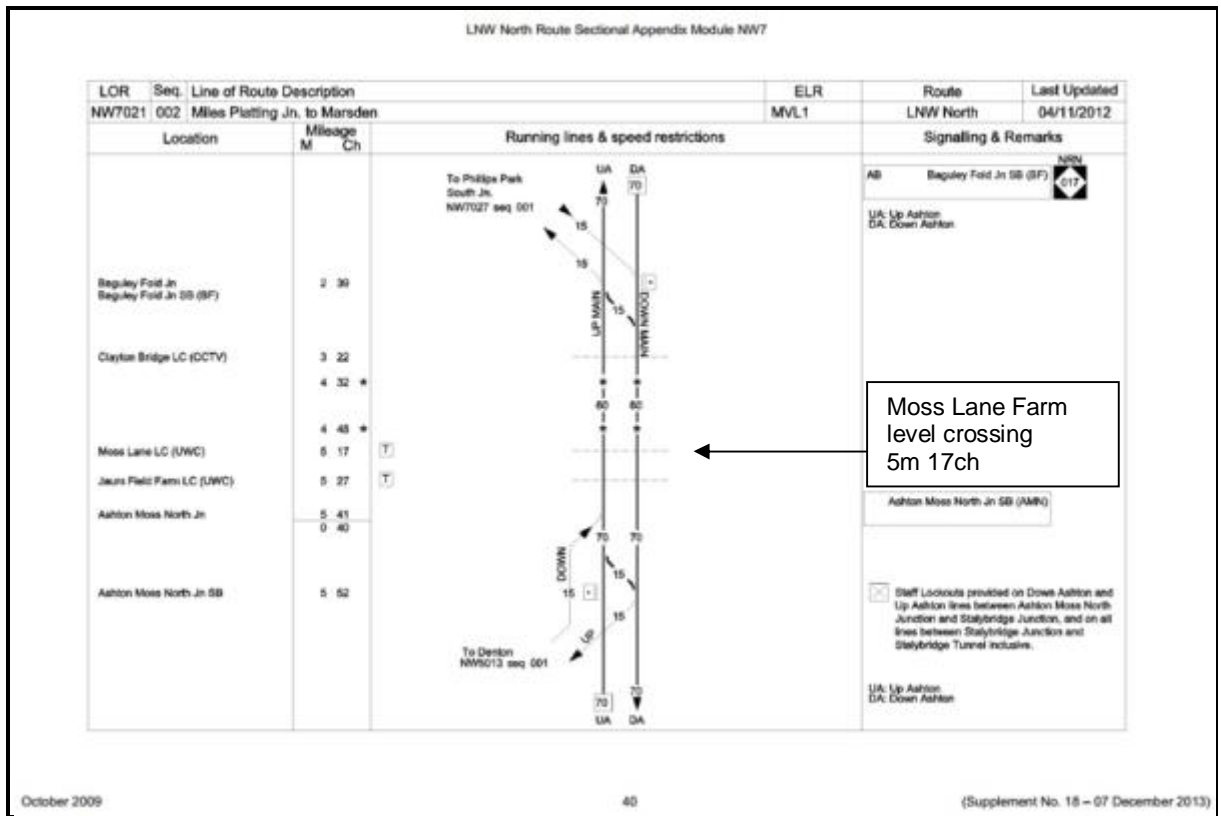
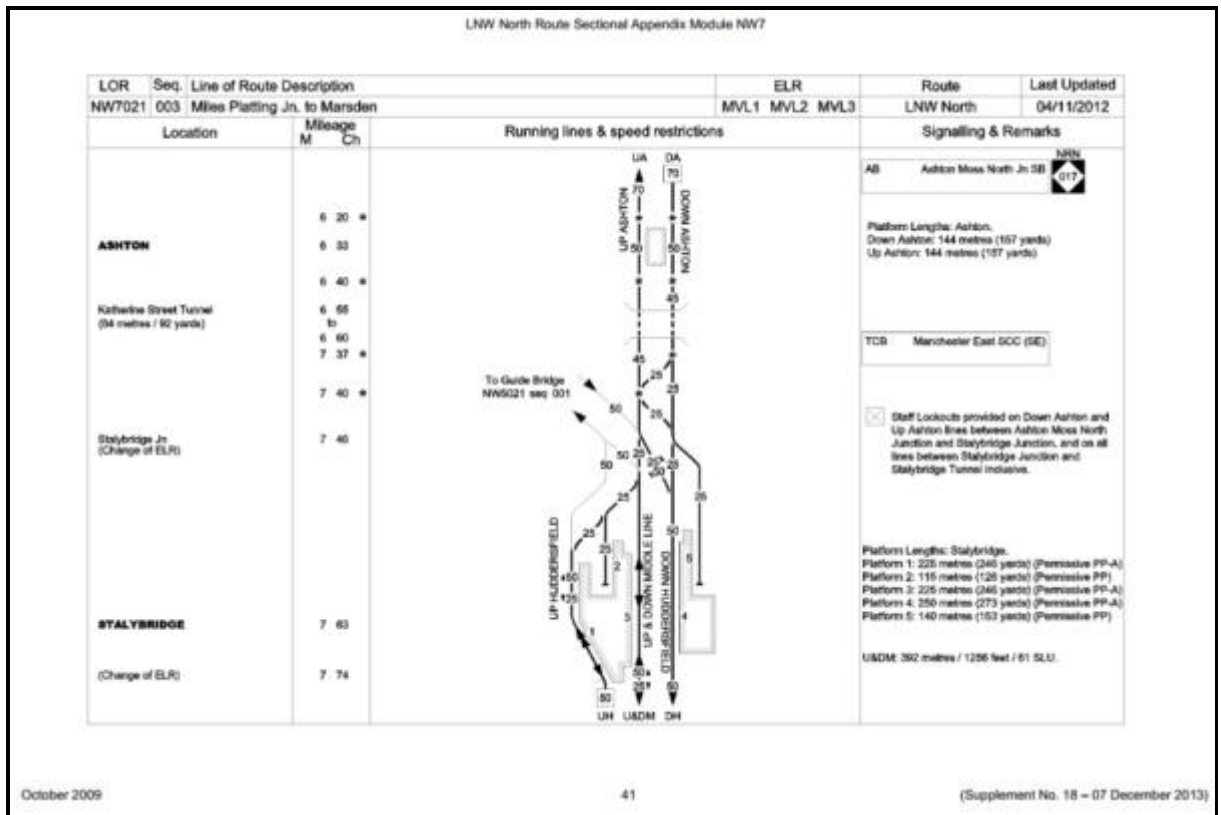
Figure 21: Sectional Appendix extract for Moss Lane Farm level crossing on Miles Platting Junction to Marsden route. November 2013

Moss Lane Farm level crossing is located on the line of route from Miles Platting Junction to Marsden on the uni-directional Up Ashton and Down Ashton lines. The nearest railway station in the Down direction (towards Marsden) is Ashton Under Lyne, which is situated 1.2 miles away. The nearest railway station in the Up direction is Manchester Victoria, which is 5.1 miles away. The crossing is a User Worked Crossing with wicker gates and has fencing along both sides of the railway where the footpath meets with the lineside.

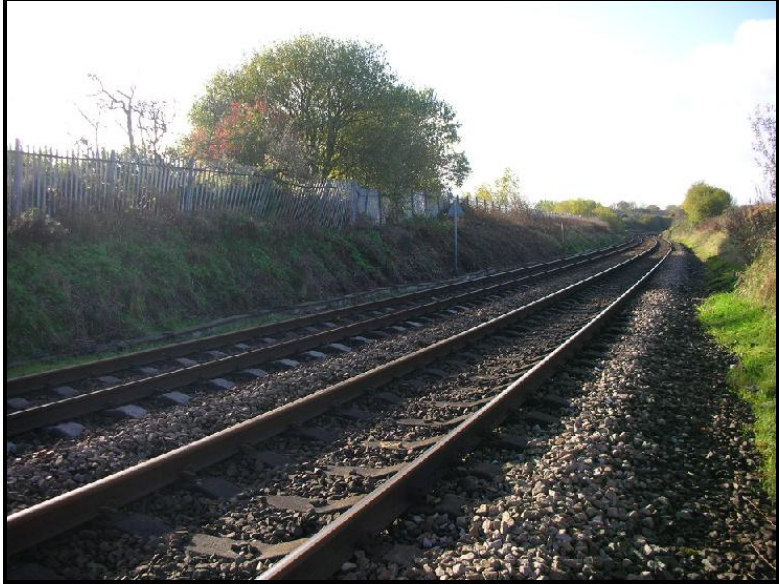
<p>Dt – D at 2 metres</p>

Considering the sighting measurements captured, the only position which would provide adequate sighting would be Ut-D with a pedestrian positioned at 2 metres from the running rail. Considering the general sighting measurements captured for the required sighting of a train being observed by a pedestrian, under the current TSR and crossing configuration, the sighting alone is not adequate.

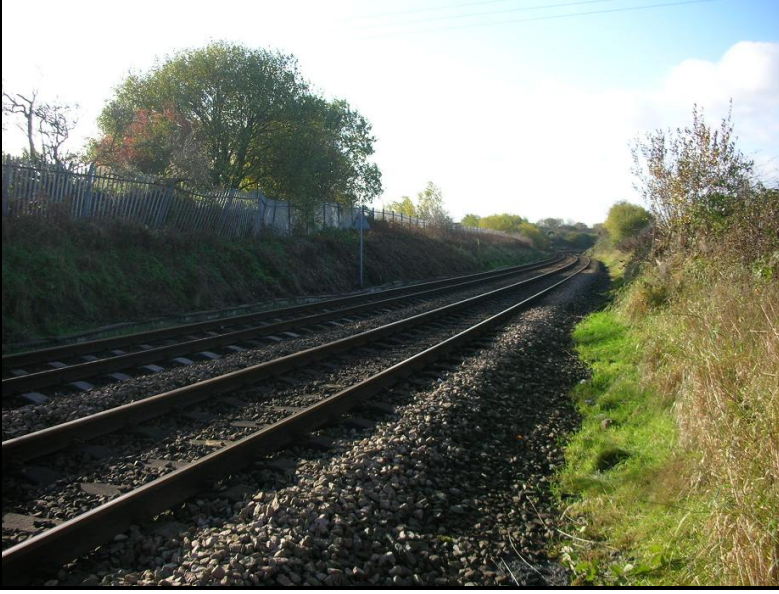
<p>Dt – U at 2 metres</p>

A photograph showing a perspective view of two parallel railway tracks, similar to the one above. The tracks are made of dark metal rails on a bed of grey gravel. To the left of the tracks, there is a grassy embankment topped with a silver metal fence. In the background, there are several trees with green and some autumn-colored foliage under a clear blue sky. The tracks recede into the distance on the right side of the frame.

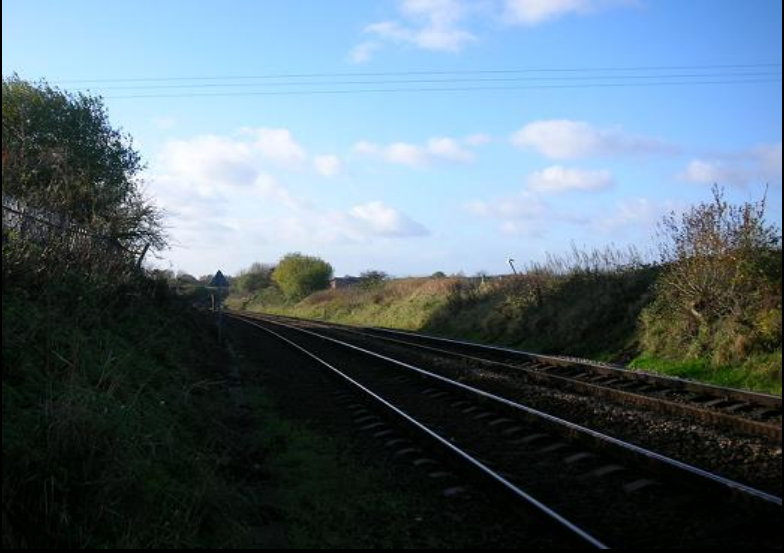
A photograph showing a perspective view of railway tracks receding into the distance. The tracks are flanked by dense green vegetation on the left and a grassy embankment on the right. The sky is blue with scattered white clouds.
<p>Dt – U at 3 metres</p>

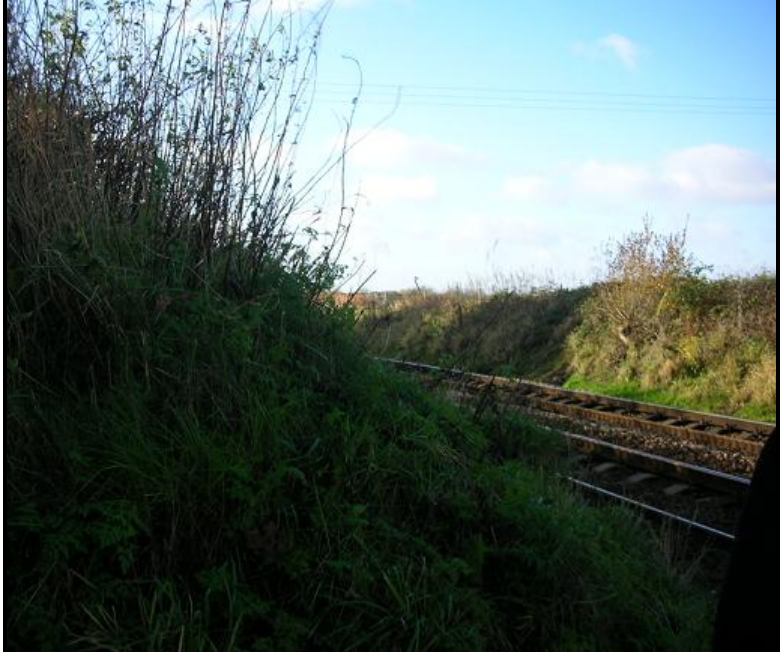
A photograph taken from a closer perspective than the first, showing the railway tracks curving slightly to the right. The foreground is dominated by tall, dark green grasses and reeds on the left side. The sky is bright blue with light clouds.
<p>Dt – U at decision point (2.8 metres)</p>

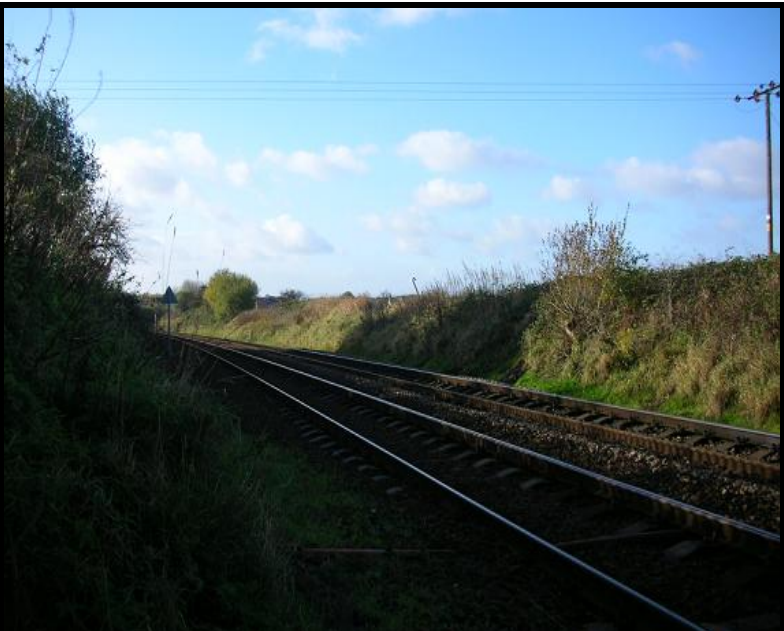
<p>Ut – D at 2 metres</p>

A photograph showing the railway tracks from a distance similar to the first image. The tracks are straight and lead towards a small structure or crossing in the distance. The vegetation on the left is dense, and the right side shows a grassy embankment. The sky is clear blue with some clouds.

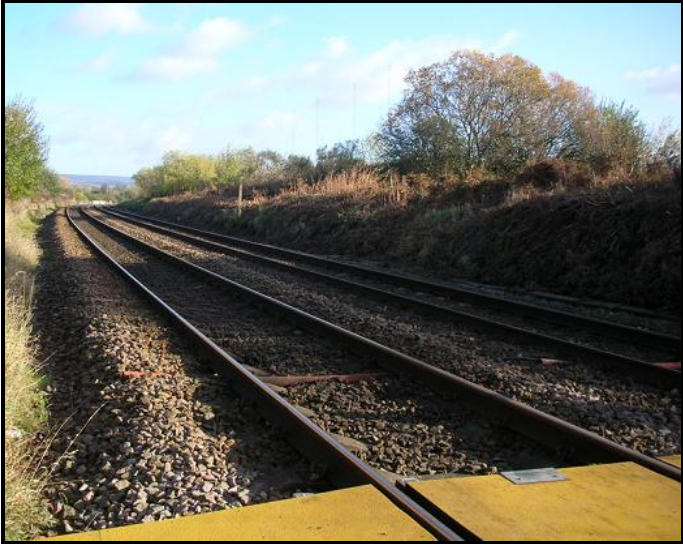
A photograph showing a perspective view of two parallel railway tracks. The tracks are made of steel rails on a bed of gravel ballast. The tracks recede into the distance under a clear blue sky with some light clouds. The surrounding area is a mix of green grass and brown, dry vegetation on a slight embankment.
<p>Ut – D at 3 metres</p>

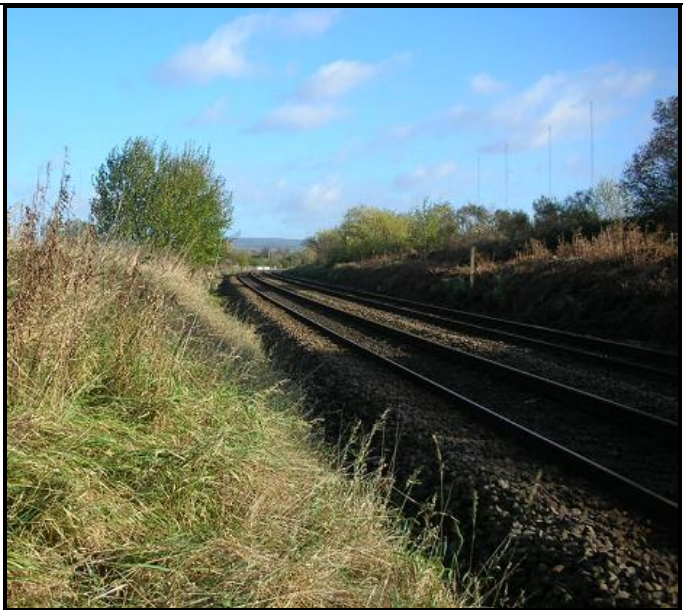
A photograph showing railway tracks from a slightly greater distance than the previous image. The tracks are more prominent in the foreground, and the surrounding vegetation, including tall grasses and trees, is more visible. The sky is bright blue with scattered white clouds.
<p>Ut – D at decision point (3.7 metres)</p>

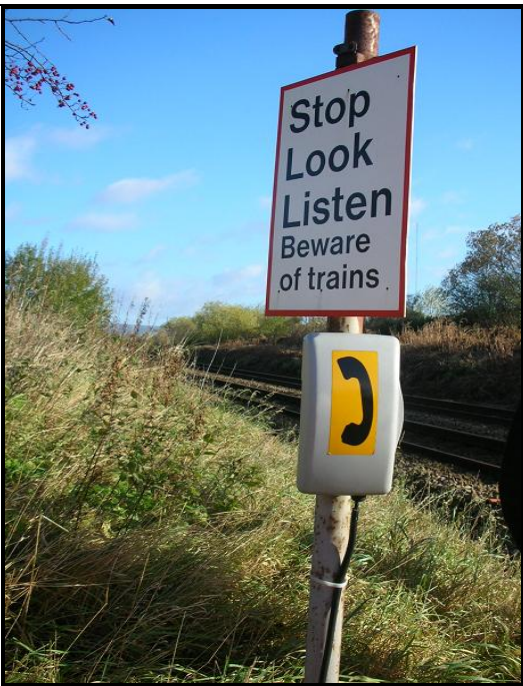
A photograph of a railway crossing sign. The sign is rectangular with a white background and a red border. It contains the text "Stop", "Look", "Listen", and "Beware of trains" in bold black letters. Below the sign is a white rectangular box with a yellow background and a black curved arrow pointing to the right. The sign is mounted on a wooden post. In the background, there are railway tracks, tall grass, and trees under a blue sky.

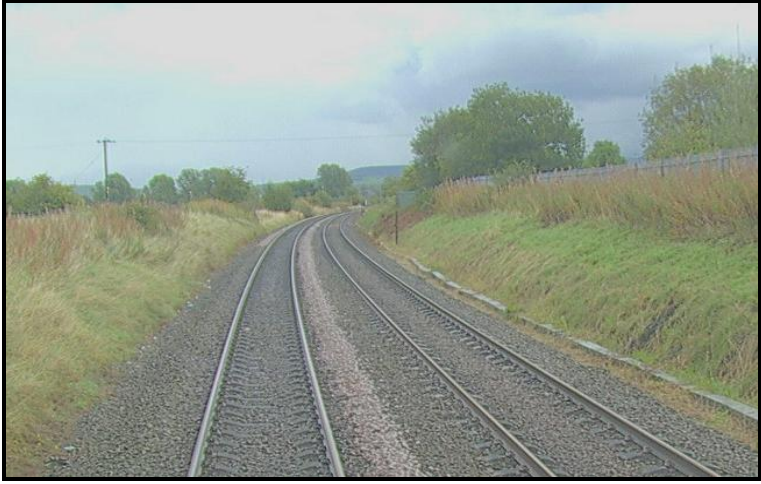
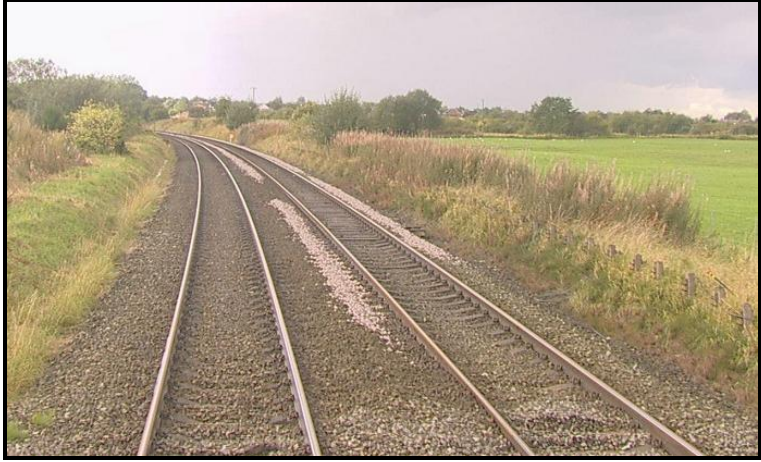
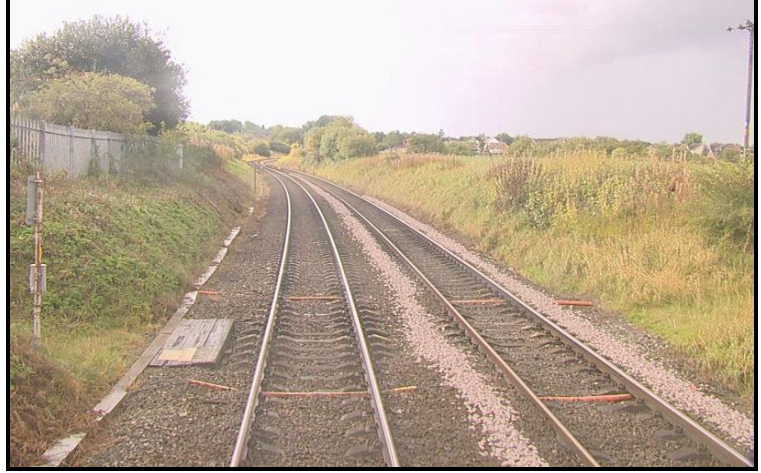
Figure 25: Images from Omnicom of train cab view of Moss Lane Farm crossing, September 2011

It is noted from Omnicom footage, dated September 2011, that whistle boards are currently not installed on the approach to Moss Lane Farm level crossing. See Section 6.4.1 of this report for further details of whistle board use at level crossings.

To facilitate a higher line speed, it may be appropriate to install whistle boards up to a maximum distance of 400 metres from the crossing, although there are considerations with regards whistle board use at Moss Lane Farm level crossing. It is noted that in the Rule book ref: GE/RT8000/TW1 Issue 8 October 2008, Section 10.2 Using the warning horn, c) Sounding the horn as a warning: Whistle boards; You must sound the horn when passing a whistle board between 0700 and 2300. You must not sound the horn when passing a whistle board between 2300 and 0700 (except in an emergency or when anyone is seen on or near the line).

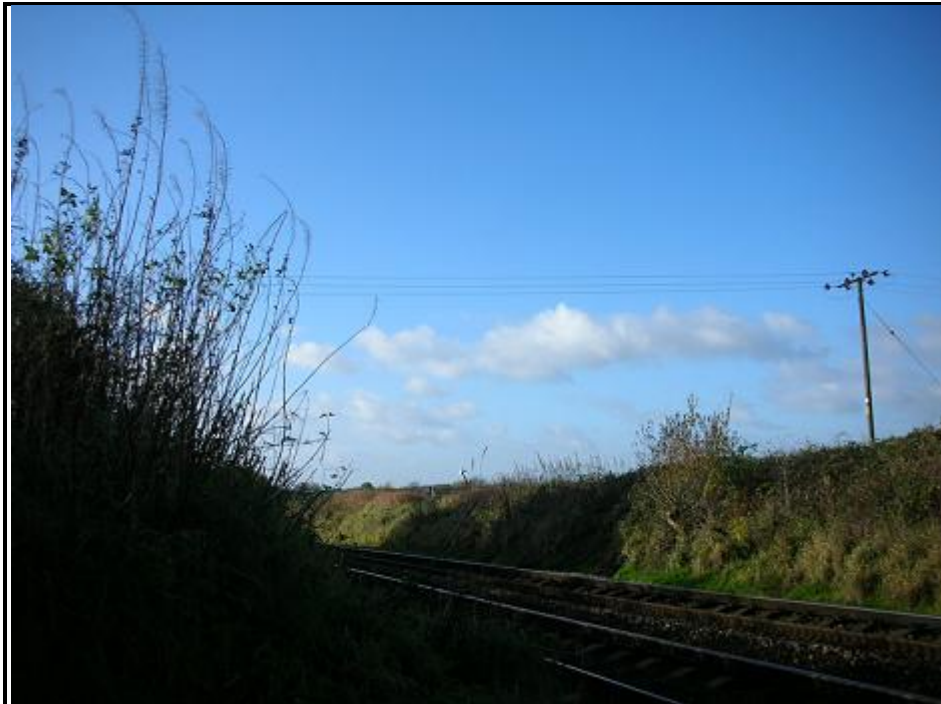
*Figure 27: Image of overhead lines passing over the railway, taken from Moss Lane Farm crossing looking west.
November 2013*

No people were observed using the crossing during the 1 hour site investigation. Stop Look and Listen signs were installed on both sides of the crossing and there was no sign of vandalism or miss use of the crossing. Overhead power lines were observed passing over the railway located between Moss Lane Farm UWC and Moss Lane Footpath crossing. The 5 mile post was observed in the Up direction, close to the crossing.

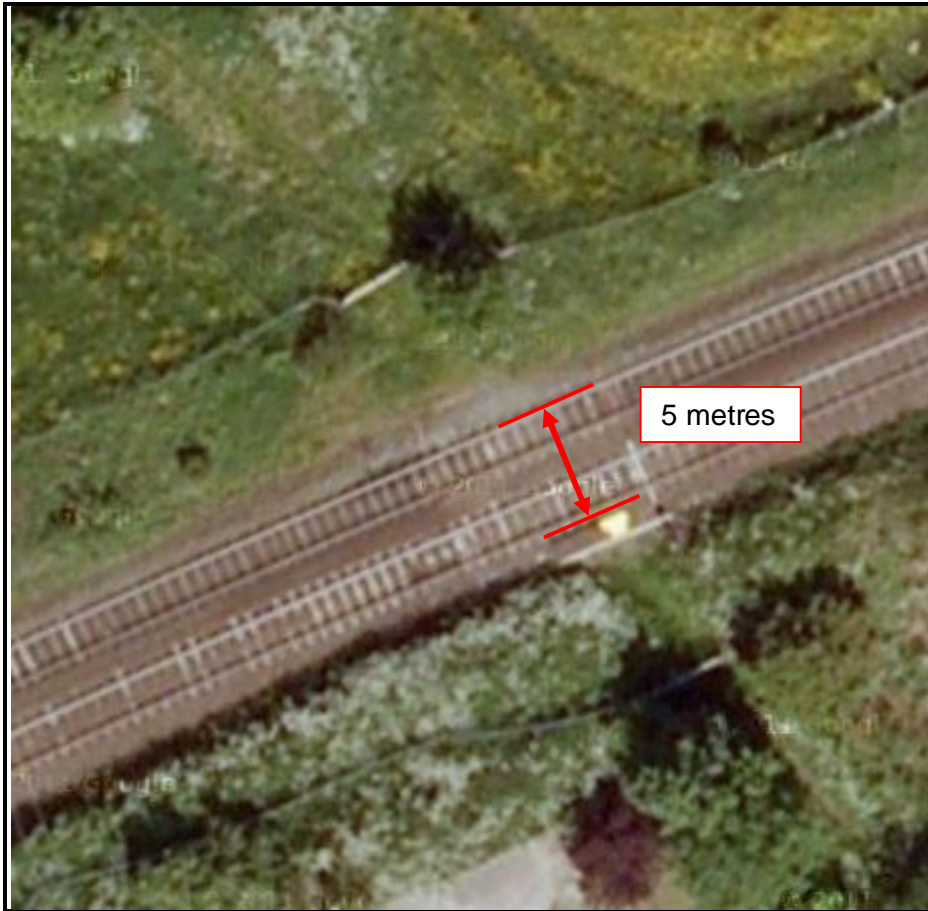
Figure 28: Aerial image of Moss Lane Farm level crossing with dimension. Image taken from Google footage.

Measurement description	Distance (metres)	Comments
Between outside rail on the Down side to the outside rail on the Up side.	5	Measurement taken from Google image
Down side: Decision point to running rail	3.7	Measurement taken from site notes
Up side: Decision point to running rail	2.8	Measurement taken from site notes.
Decision point to Decision point	11.5	Measurement taken from site and Google image.

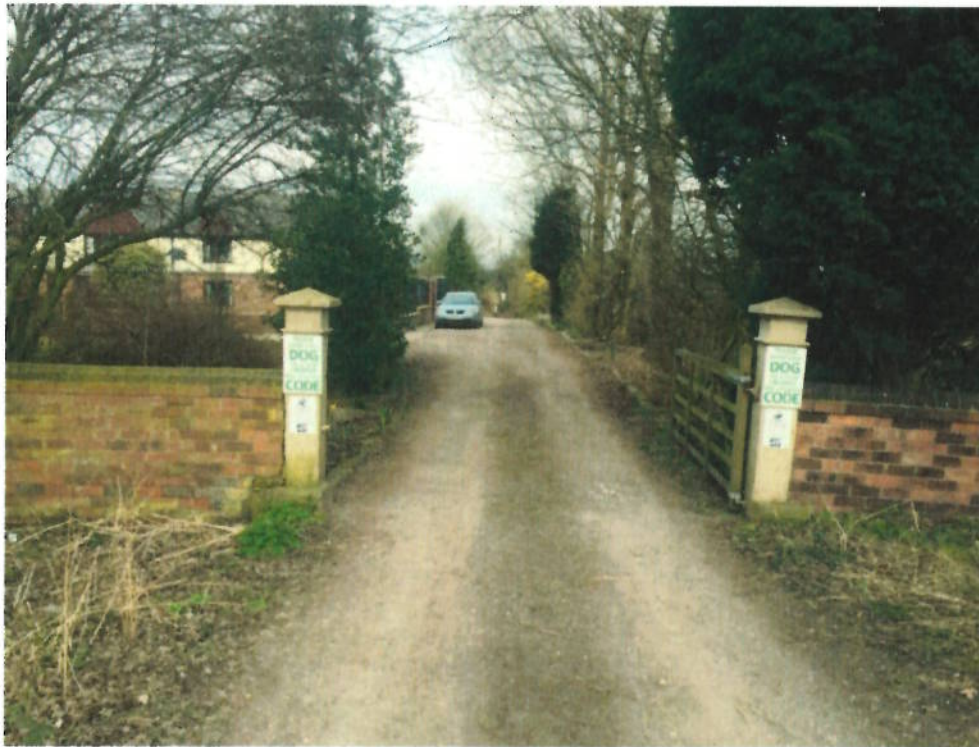
South approach from Moss Lane past residential property

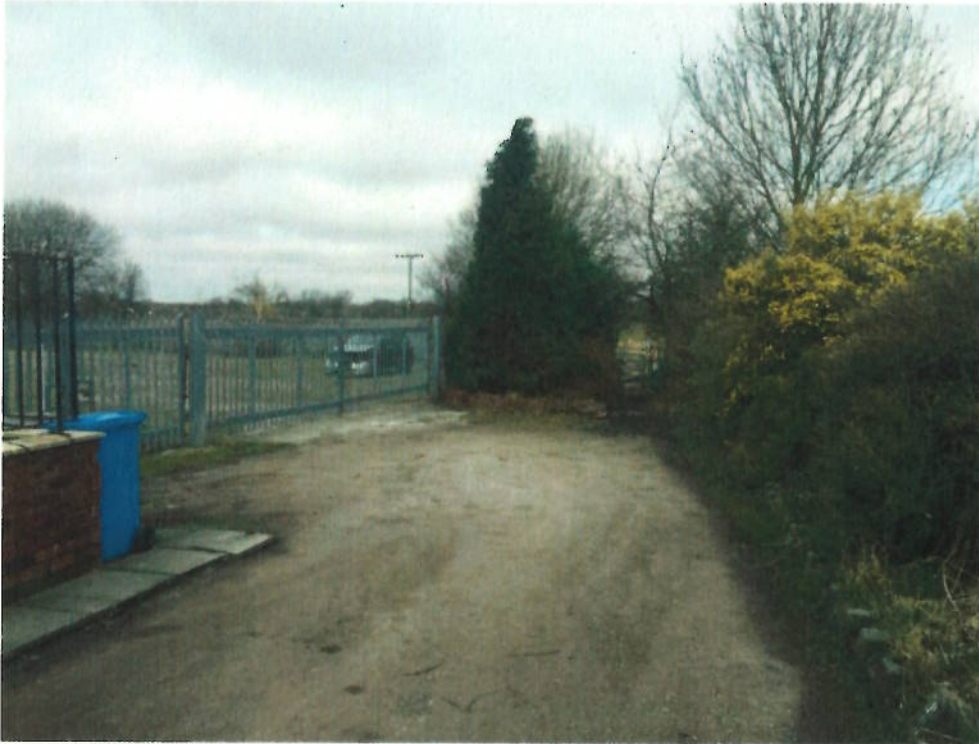
Approach to south of residential property

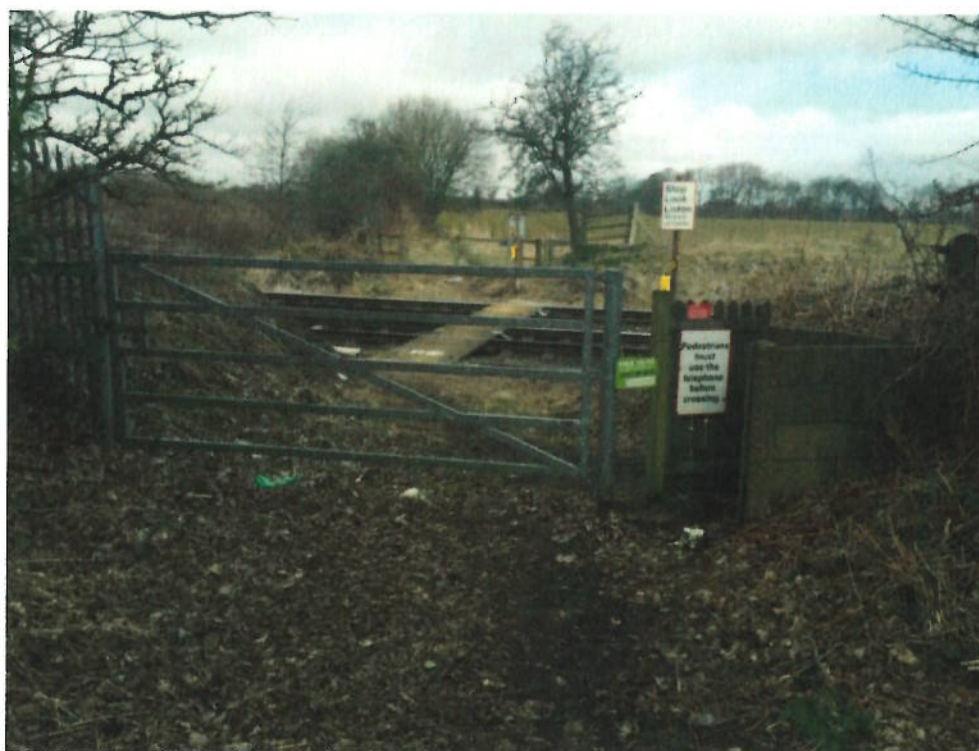
Fence / gate to south of crossing

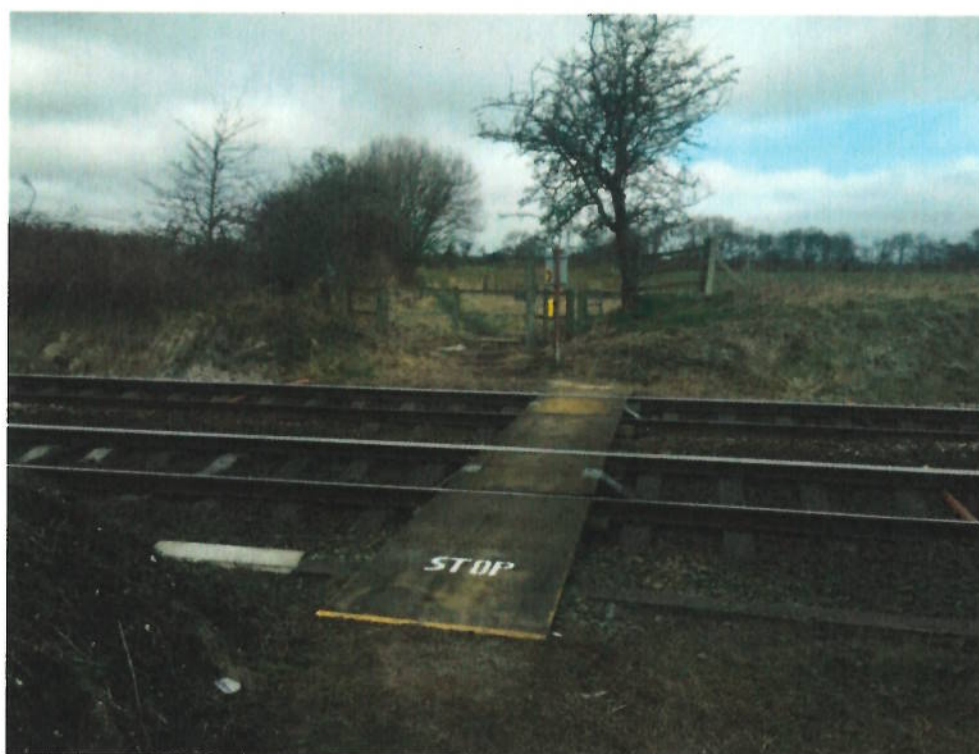
View of crossing from south looking north

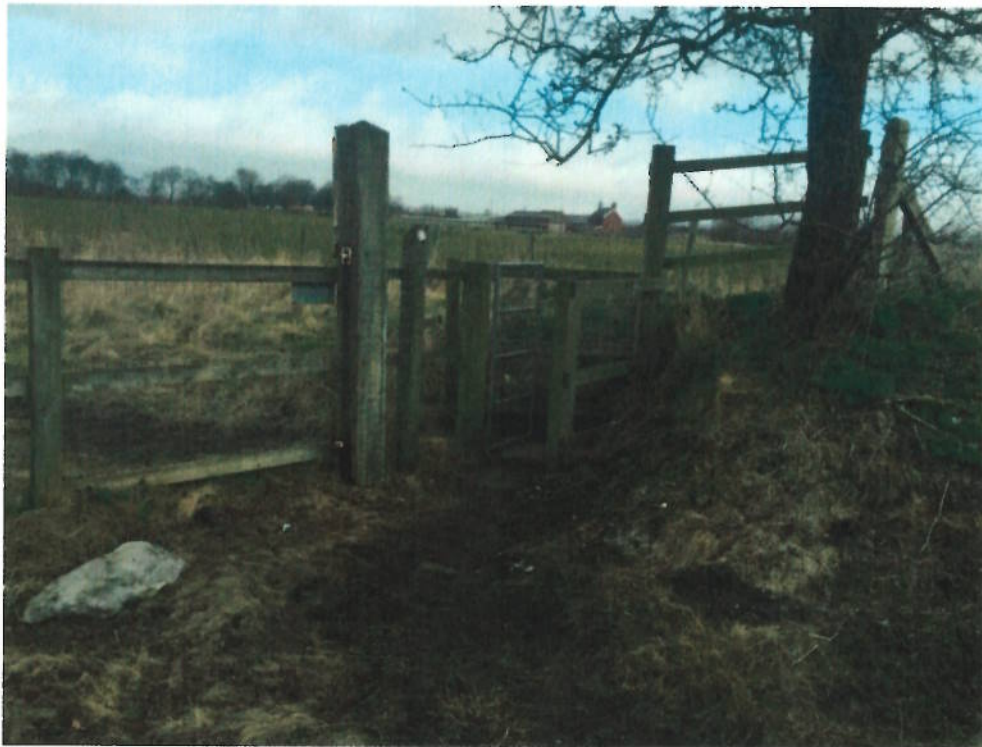
Fence / gate to north of crossing

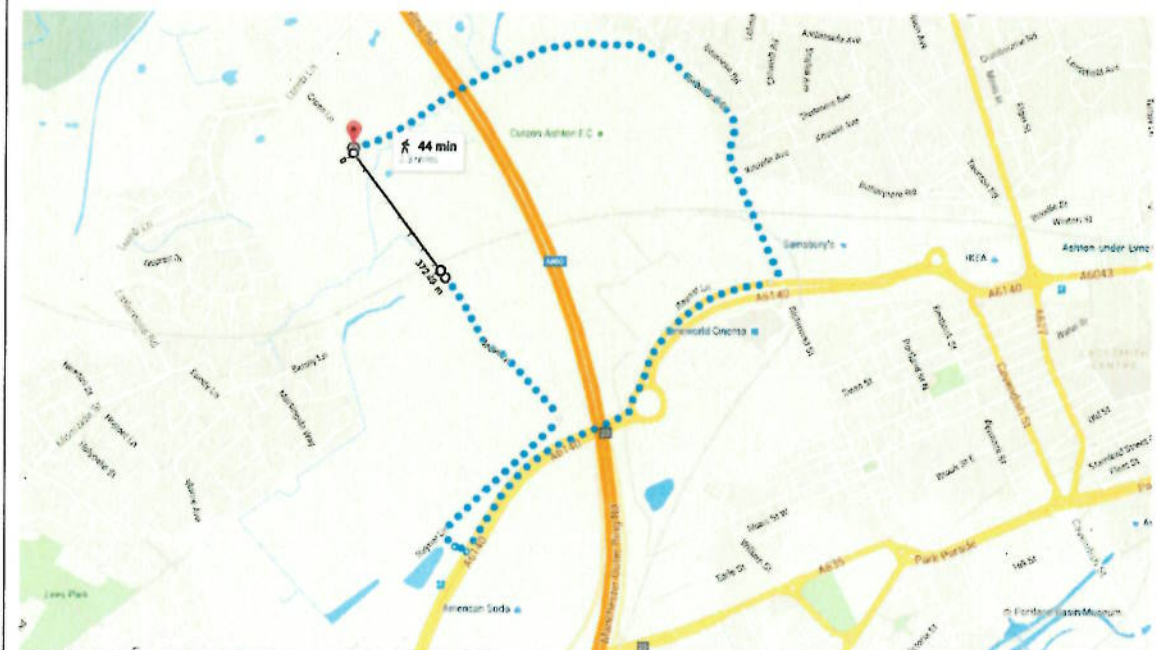
If the level crossing was closed either on a temporary or permanent basis, the logical first choice diversion route would involve travelling back down Moss Lane and Raynor Lane to the south, along the A6140, to Richmond Street then Cross Lane to the north, this diversion would take approximately 45 minutes and is 2.3 miles in length. It is also worth noting that there are several sections of the route that do not have footpaths.
