DEMOLITION SURVEY
DENTON SWIMMING POOL
VICTORIA STREET
DENTON
MANCHESTER

Report prepared for:	AA Woods Holding Ltd Alma Street St Helens WA9 3AR
Report reference:	J180264
Issue date:	March 2020
Survey completed by: Karl Koffman Senior Surveyor

A Demolition Survey of Denton Swimming Pool, Victoria Street, Denton, Manchester, , M34 3GU, has been undertaken by AEC.

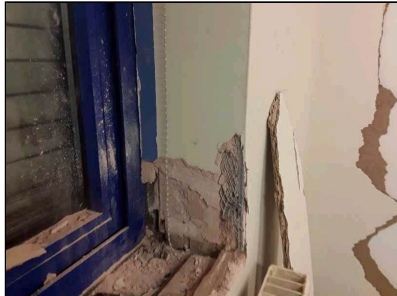
Location:		Demolition Survey - 10.03.20. to 16.03.20 - Ground floor - A - 019 - Office - Bitumen felt damp proof membrane sandwiched within the cavity of the brick wall

Item No:	000013	Laboratory sample no:	FB004018	
Accessibility:		Moderate		
Installation:		Felt (1)		
Approx extent (m ² unless stated)		Throughout		
Asbestos Type:		Chrysotile (1)		
Condition:		Low damage (1)	Surface Treatment: Completely sealed (0)

Material Risk Assessment	3	Priority Risk Assessment (PA)	N/A	Total Risk	N/A
Recommendation:	Remove				
Comments: This is likely to be throughout the building

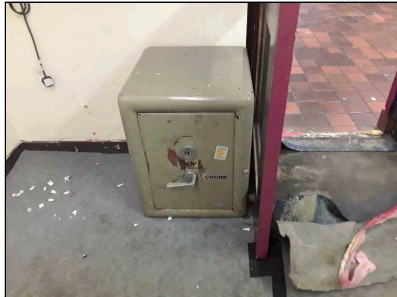
Location:		Demolition Survey - 10.03.20. to 16.03.20 - Ground floor - A - 019 - Office - No access within the locked safe

Item No:	000014	Laboratory sample no:	Not sampled	
Accessibility:		No access gained		
Installation:		Unknown (3)		
Approx extent (m ² unless stated)		Unknown		
Asbestos Type:		Presumed asbestos (3)		
Condition:		High damage (3)	Surface Treatment: Unsealed (3)

Material Risk Assessment	12	Priority Risk Assessment (PA)	N/A	Total Risk	12
Recommendation:	Presume ACMs are present until area has been surveyed				
Comments: No keys made available, sometimes safes contain asbestos textiles around the edge of the door.

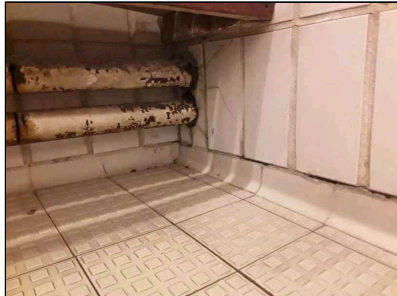
Location:		Demolition Survey - 10.03.20. to 16.03.20 - Ground floor - A - 006 - Changing Area - Lagging to the pipe that runs at low level below bench in cubicles

Item No:	000019	Laboratory sample no:	FB004021	
Accessibility:	N/A			
Installation:	Insulation			
Approx extent (m ² unless stated)	N/A			
Asbestos Type:	NAD			
Condition:	N/A	Surface Treatment:	N/A

Material Risk Assessment	0	Priority Risk Assessment (PA)	N/A	Total Risk	
Recommendation:	None				
Comments: Where it runs through the wall it was sampled

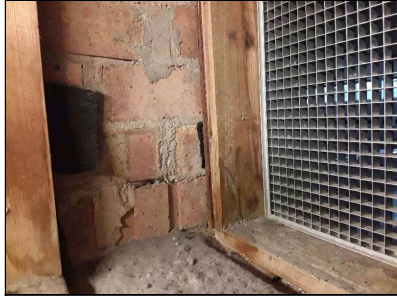
Location:		Demolition Survey - 10.03.20. to 16.03.20 - Ground floor - A - 006 - Changing Area - Felt packers to sandwiched between wall and the timbers behind ventilation grilles

Item No:	000020	Laboratory sample no:	SP FB004017	
Accessibility:	N/A			
Installation:	Felt			
Approx extent (m ² unless stated)	N/A			
Asbestos Type:	NAD			
Condition:	N/A	Surface Treatment:	N/A

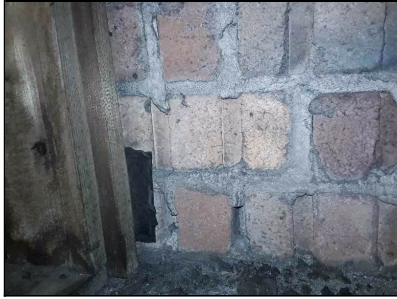
Location:	Demolition Survey - 10.03.20. to 16.03.20 - Ground floor - A - 014 - Changing Area - Felt packers sandwiched between the timber frame and the brickwork of the large vent to the left wall

Item No:	000023	Laboratory sample no:	SP FB004017	
Accessibility:	N/A			
Installation:	Felt			
Approx extent (m ² unless stated)	N/A			
Asbestos Type:	NAD			
Condition:	N/A	Surface Treatment:	N/A

Material Risk Assessment	0	Priority Risk Assessment (PA)	N/A	Total Risk	
Recommendation:	None				
Comments: No access to the top section of the ventilation shaft as it is too confined a space to access

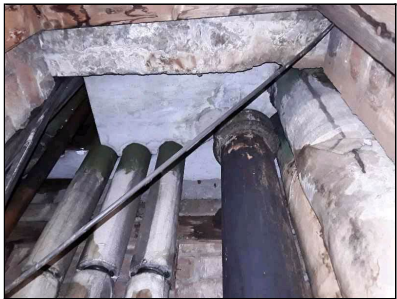
Location:	Demolition Survey - 10.03.20. to 16.03.20 - Ground floor - A - 014 - Changing Area - Boarding sealing off the top of the riser (accessed from end changing cubicle)

Item No:	000024	Laboratory sample no:	FB004024	
Accessibility:	Moderate			
Installation:	Boarding (2)			
Approx extent (m ² unless stated)	1			
Asbestos Type:	Amosite (2)			
Condition:	Medium damage (2)	Surface Treatment:	Unsealed AIB/encapsulated lagging (2)

Material Risk Assessment	8	Priority Risk Assessment (PA)	N/A	Total Risk	N/A
Recommendation:	Remove				
Comments:

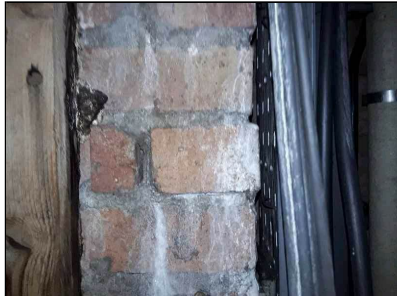
Location:		Demolition Survey - 10.03.20. to 16.03.20 - Ground floor - A - 014 - Changing Area - Felt packers behind the timber frame of the riser

Item No:	000025	Laboratory sample no:	SP FB004017	
Accessibility:	N/A			
Installation:	Felt			
Approx extent (m ² unless stated)	N/A			
Asbestos Type:	NAD			
Condition:	N/A	Surface Treatment:	N/A

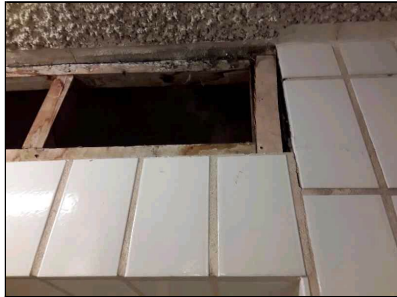
Location:		Demolition Survey - 10.03.20. to 16.03.20 - Ground floor - A - 014 - Changing Area - Felt packers around the timber frame of the ceiling level boxwork in shower area

Item No:	000026	Laboratory sample no:	SP FB004017	
Accessibility:	N/A			
Installation:	Felt			
Approx extent (m ² unless stated)	N/A			
Asbestos Type:	NAD			
Condition:	N/A	Surface Treatment:	N/A

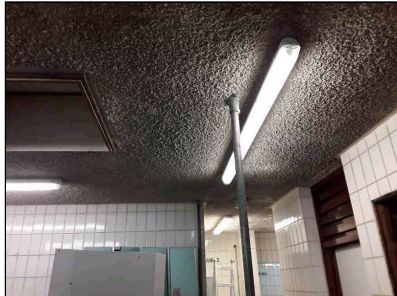
Location:		Demolition Survey - 10.03.20. to 16.03.20 - Ground floor - A - 018 - Changing Area - Spray coating to the rear section of ceiling (near showers)

Item No:	000031	Laboratory sample no:	FB004028	
Accessibility:		N/A		
Installation:		Sprayed coating		
Approx extent (m ² unless stated)		N/A		
Asbestos Type:		NAD		
Condition:	N/A	Surface Treatment:	N/A

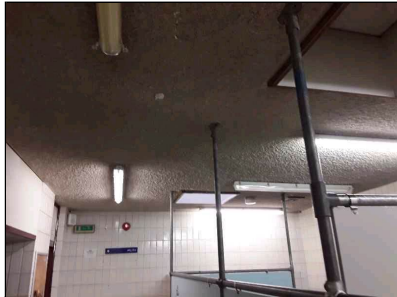
Location:		Demolition Survey - 10.03.20. to 16.03.20 - Ground floor - A - 018 - Changing Area - Spray coating to the front section of the ceiling

Item No:	000032	Laboratory sample no:	FB004029	
Accessibility:		N/A		
Installation:		Sprayed coating		
Approx extent (m ² unless stated)		N/A		
Asbestos Type:		NAD		
Condition:	N/A	Surface Treatment:	N/A

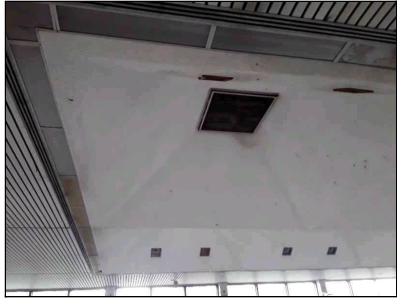
Location:		Demolition Survey - 10.03.20. to 16.03.20 - Ground floor - A - 008 - Pool Area - Spray coating to the ceiling (left side)

Item No:	000039	Laboratory sample no:	FB004036	
Accessibility:		Moderate		
Installation:		Sprayed coating (3)		
Approx extent (m ² unless stated)		>200		
Asbestos Type:		Chrysotile + Amosite (2)		
Condition:		Low damage (1)	Surface Treatment:	Unsealed AIB/encapsulated lagging (2)

Material Risk Assessment	8	Priority Risk Assessment (PA)	N/A	Total Risk	N/A
Recommendation:	Remove				
Comments:

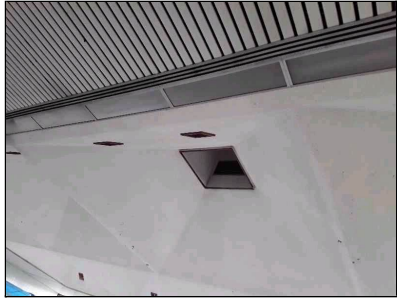
Location:	Demolition Survey - 10.03.20. to 16.03.20 - Ground floor - A - 008 - Pool Area - Spray coating to the ceiling (near side)

Item No:	000041	Laboratory sample no:	FB004038	
Accessibility:	Moderate			
Installation:	Sprayed coating (3)			
Approx extent (m ² unless stated)	>200			
Asbestos Type:	Chrysotile + Amosite (2)			
Condition:	Low damage (1)	Surface Treatment:	Unsealed AIB/encapsulated lagging (2)

Material Risk Assessment	8	Priority Risk Assessment (PA)	N/A	Total Risk	N/A
Recommendation:	Remove				
Comments:

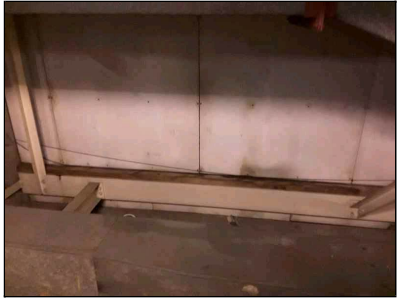
Location:		Demolition Survey - 10.03.20. to 16.03.20 - Roof Void - Roof void above pools - Boarding to right wall (above small pool)

Item No:	000043	Laboratory sample no:	FB004040	
Accessibility:		Moderate		
Installation:		Boarding (2)		
Approx extent (m ² unless stated)		>300		
Asbestos Type:		Amosite (2)		
Condition:		Low damage (1)	Surface Treatment:	Unsealed AIB/encapsulated lagging (2)

Material Risk Assessment	7	Priority Risk Assessment (PA)	N/A	Total Risk	N/A
Recommendation:	Remove				
Comments:

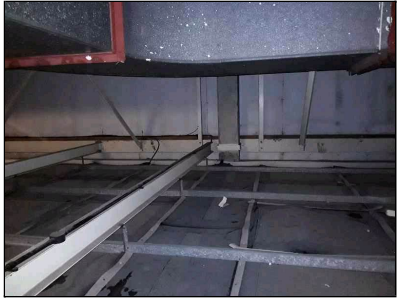
Location:		Demolition Survey - 10.03.20. to 16.03.20 - Roof Void - Roof void above pools - Boarding to left wall (above large pool)

Item No:	000047	Laboratory sample no:	FB004044	
Accessibility:	Moderate			
Installation:	Boarding (2)			
Approx extent (m ² unless stated)	>300			
Asbestos Type:	Amosite (2)			
Condition:	Low damage (1)	Surface Treatment:	Unsealed AIB/encapsulated lagging (2)

Material Risk Assessment	7	Priority Risk Assessment (PA)	N/A	Total Risk	N/A
Recommendation:	Remove				
Comments:

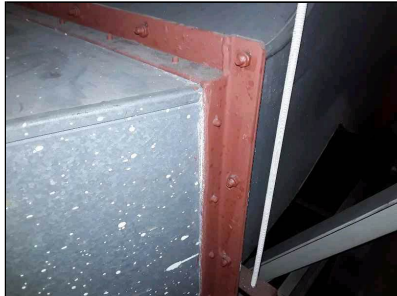
Location:		Demolition Survey - 10.03.20. to 16.03.20 - Roof Void - Roof void above pools - Mastic (white) around exterior of red brackets of ductwork

Item No:	000055	Laboratory sample no:	FB004050	
Accessibility:	N/A			
Installation:	Mastic			
Approx extent (m ² unless stated)	N/A			
Asbestos Type:	NAD			
Condition:	N/A	Surface Treatment:	N/A

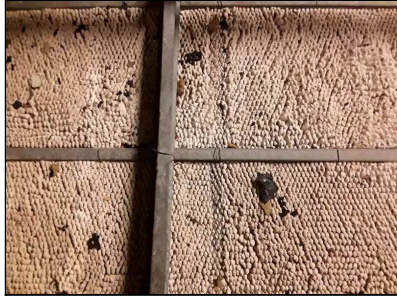
Location:		Demolition Survey - 10.03.20. to 16.03.20 - Roof Void - Roof void above pools - Felt underscore fragments to the rear of pool ceiling

Item No:	000056	Laboratory sample no:	FB004051	
Accessibility:	N/A			
Installation:	Felt			
Approx extent (m ² unless stated)	N/A			
Asbestos Type:	NAD			
Condition:	N/A	Surface Treatment:	N/A

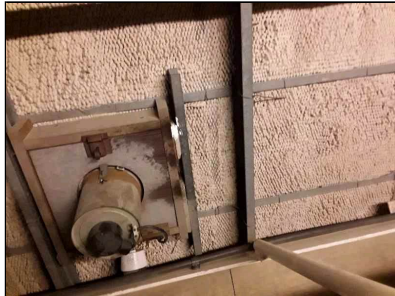
Location:		Demolition Survey - 10.03.20. to 16.03.20 - Roof Void - Roof void above pools - Boarding packers to timber frame of light built into pool ceiling

Item No:	000057	Laboratory sample no:	FB004052	
Accessibility:	Easy			
Installation:	Boarding (2)			
Approx extent (m ² unless stated)	2no.			
Asbestos Type:	Amosite (2)			
Condition:	Medium damage (2)	Surface Treatment:	Unsealed AIB/encapsulated lagging (2)

Material Risk Assessment	8	Priority Risk Assessment (PA)	N/A	Total Risk	N/A
Recommendation:	Remove				
Comments:

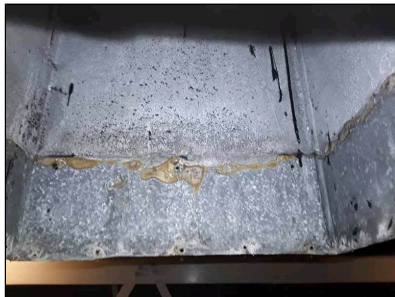
Location:		Demolition Survey - 10.03.20. to 16.03.20 - Roof Void - Roof void above pools - Bitumen residues to ductwork

Item No:	000058	Laboratory sample no:	FB004053	
Accessibility:	N/A			
Installation:	Bitumen			
Approx extent (m ² unless stated)	N/A			
Asbestos Type:	NAD			
Condition:	N/A	Surface Treatment:	N/A

Material Risk Assessment	0	Priority Risk Assessment (PA)	N/A	Total Risk	
Recommendation:	None				
Comments:	Negative sampling (probably tar that has leaked through from external flat roof)

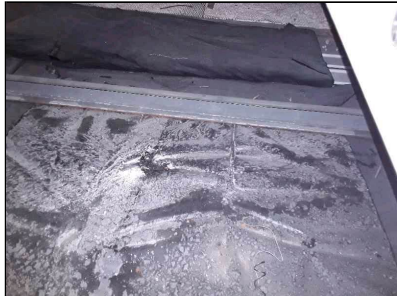
Location:		Demolition Survey - 10.03.20. to 16.03.20 - Roof Void - Roof void above pools - Spray coating debris to top of the insulation (throughout - small amounts)

Item No:	000059	Laboratory sample no:	FB004054	
Accessibility:		N/A		
Installation:		Debris		
Approx extent (m ² unless stated)		N/A		
Asbestos Type:		NAD		
Condition:		N/A	Surface Treatment: N/A

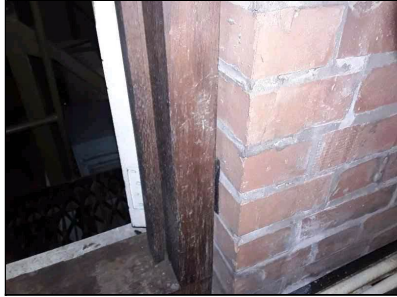
Location:		Demolition Survey - 10.03.20. to 16.03.20 - Roof Void - Roof void above pools - Felt packers around the timber frame of the door to roof void

Item No:	000060	Laboratory sample no:	SP FB004017	
Accessibility:		N/A		
Installation:		Felt		
Approx extent (m ² unless stated)		N/A		
Asbestos Type:		NAD		
Condition:		N/A	Surface Treatment: N/A

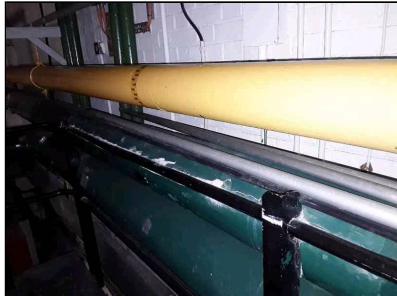
Location:	Demolition Survey - 10.03.20. to 16.03.20 - Ground floor - A - 012 - Plant room - Lagging to upper green pipe run where it runs level with gantry

Item No:	000063	Laboratory sample no:	FB004056	
Accessibility:	N/A			
Installation:	Insulation			
Approx extent (m ² unless stated)	N/A			
Asbestos Type:	NAD			
Condition:	N/A	Surface Treatment:	N/A

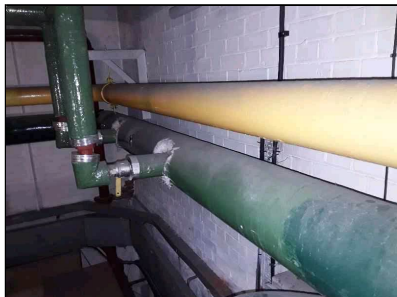
Location:	Demolition Survey - 10.03.20. to 16.03.20 - Ground floor - A - 012 - Plant room - Lagging to upper green pipe run where it continues along wall

Item No:	000064	Laboratory sample no:	FB004057	
Accessibility:	N/A			
Installation:	Insulation			
Approx extent (m ² unless stated)	N/A			
Asbestos Type:	NAD			
Condition:	N/A	Surface Treatment:	N/A

Material Risk Assessment	0	Priority Risk Assessment (PA)	N/A	Total Risk	
Recommendation:	None				
Comments:

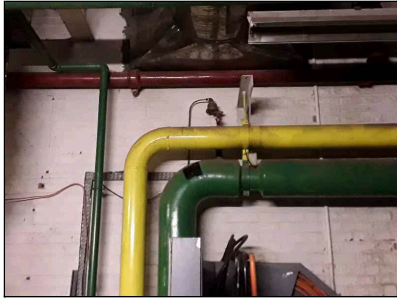
Location:		Demolition Survey - 10.03.20. to 16.03.20 - Ground floor - A - 012 - Plant room - Lagging to elbow of upper green pipe

Item No:	000067	Laboratory sample no:	FB004060	
Accessibility:	N/A			
Installation:	Insulation			
Approx extent (m ² unless stated)	N/A			
Asbestos Type:	NAD			
Condition:	N/A	Surface Treatment:	N/A

Material Risk Assessment	0	Priority Risk Assessment (PA)	N/A	Total Risk	
Recommendation:	None				
Comments: Where it turns and runs do the far wall

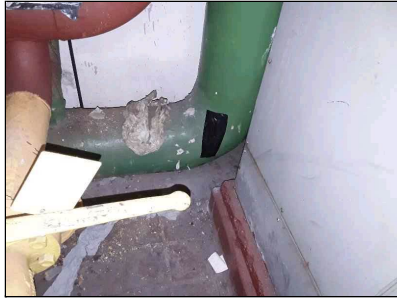
Location:		Demolition Survey - 10.03.20. to 16.03.20 - Ground floor - A - 012 - Plant room - Lagging to elbow of upper green pipe

Item No:	000069	Laboratory sample no:	FB004062	
Accessibility:		N/A		
Installation:		Insulation		
Approx extent (m ² unless stated)		N/A		
Asbestos Type:		NAD		
Condition:		N/A	Surface Treatment:

Material Risk Assessment	0	Priority Risk Assessment (PA)	N/A	Total Risk	
Recommendation:		None			
Comments: Where it runs level with the floor

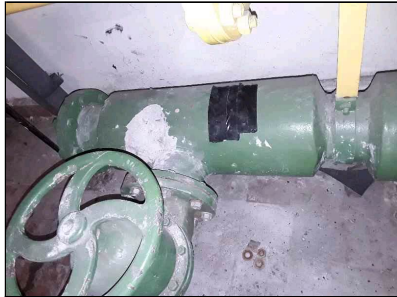
Location:		Demolition Survey - 10.03.20. to 16.03.20 - Ground floor - A - 012 - Plant room - Lagging to upper green pipe where it runs at floor level (to back of boilers)

Item No:	000071	Laboratory sample no:	FB004064	
Accessibility:		N/A		
Installation:		Insulation		
Approx extent (m ² unless stated)		N/A		
Asbestos Type:		NAD		
Condition:		N/A	Surface Treatment: N/A

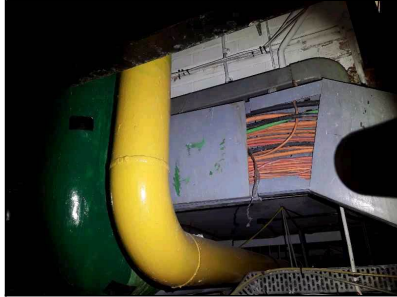
Location:		Demolition Survey - 10.03.20. to 16.03.20 - Ground floor - A - 012 - Plant room - Lagging to upper green pipe where it runs down wall (before leaving plant room entering pool area)

Item No:	000072	Laboratory sample no:	FB004065	
Accessibility:		N/A		
Installation:		Insulation		
Approx extent (m ² unless stated)		N/A		
Asbestos Type:		NAD		
Condition:		N/A	Surface Treatment: N/A

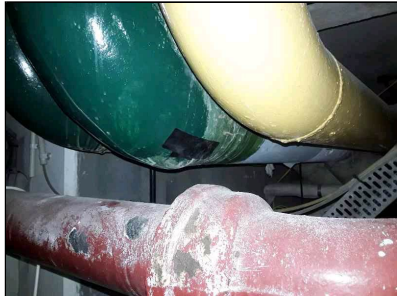
Location:		Demolition Survey - 10.03.20. to 16.03.20 - Ground floor - A - 012 - Plant room - Lagging to upper green pipe elbow where it runs to enter pool area

Item No:	000073	Laboratory sample no:	FB004066	
Accessibility:	N/A			
Installation:	Insulation			
Approx extent (m ² unless stated)	N/A			
Asbestos Type:	NAD			
Condition:	N/A	Surface Treatment:	N/A

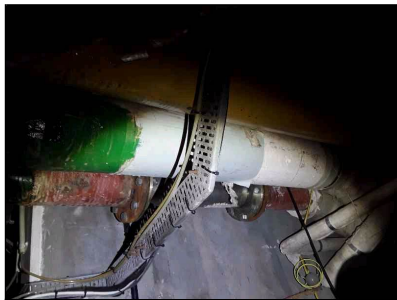
Location:		Demolition Survey - 10.03.20. to 16.03.20 - Ground floor - A - 012 - Plant room - Lagging to upper green pipe where it begins it's run below pool

Item No:	000074	Laboratory sample no:	FB004067	
Accessibility:	N/A			
Installation:	Insulation			
Approx extent (m ² unless stated)	N/A			
Asbestos Type:	NAD			
Condition:	N/A	Surface Treatment:	N/A

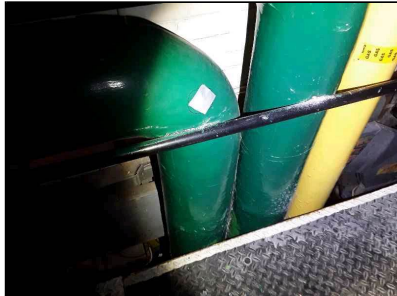
Location:		Demolition Survey - 10.03.20. to 16.03.20 - Ground floor - A - 012 - Plant room - Lagging to lower green pipe (large bore) at elbow with gantry

Item No:	000075	Laboratory sample no:	FB004068	
Accessibility:		N/A		
Installation:		Insulation		
Approx extent (m ² unless stated)		N/A		
Asbestos Type:		NAD		
Condition:	N/A	Surface Treatment:	N/A

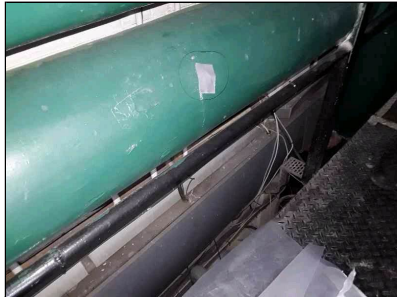
Location:		Demolition Survey - 10.03.20. to 16.03.20 - Ground floor - A - 012 - Plant room - Lagging to lower green pipe run level with gantry

Item No:	000076	Laboratory sample no:	FB004069	
Accessibility:		N/A		
Installation:		Insulation		
Approx extent (m ² unless stated)		N/A		
Asbestos Type:		NAD		
Condition:	N/A	Surface Treatment:	N/A

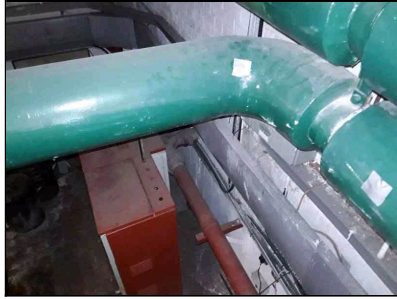
Location:		Demolition Survey - 10.03.20. to 16.03.20 - Ground floor - A - 012 - Plant room - Lagging to lower green pipe at elbow (above distribution box)

Item No:	000078	Laboratory sample no:	FB004071	
Accessibility:		N/A		
Installation:		Insulation		
Approx extent (m ² unless stated)		N/A		
Asbestos Type:		NAD		
Condition:		N/A	Surface Treatment:

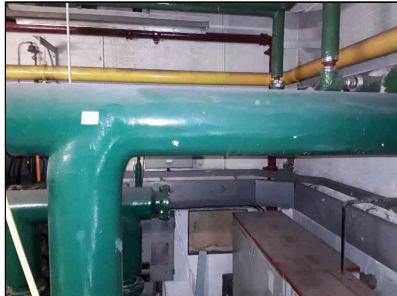
Location:		Demolition Survey - 10.03.20. to 16.03.20 - Ground floor - A - 012 - Plant room - Lagging to run of lower green pipe (section adjacent stairs)

Item No:	000079	Laboratory sample no:	FB004072	
Accessibility:	N/A			
Installation:	Insulation			
Approx extent (m ² unless stated)	N/A			
Asbestos Type:	NAD			
Condition:	N/A	Surface Treatment:	N/A

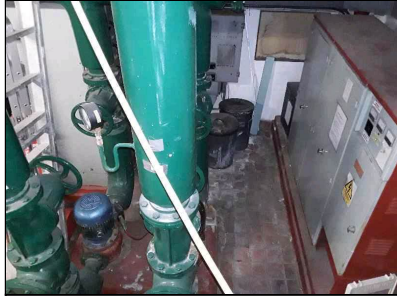
Location:		Demolition Survey - 10.03.20. to 16.03.20 - Ground floor - A - 012 - Plant room - Lagging where lower green pipe runs/branches off towards the floor

Item No:	000080	Laboratory sample no:	FB004073	
Accessibility:	N/A			
Installation:	Insulation			
Approx extent (m ² unless stated)	N/A			
Asbestos Type:	NAD			
Condition:	N/A	Surface Treatment:	N/A

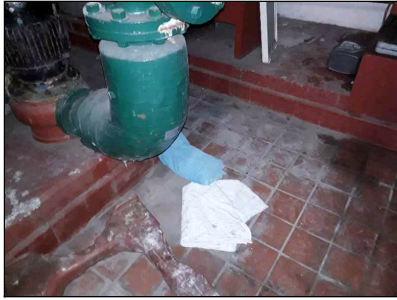
Location:	Demolition Survey - 10.03.20. to 16.03.20 - Ground floor - A - 012 - Plant room - Lagging to lower green pipe elbow at floor level

Item No:	000081	Laboratory sample no:	FB004074	
Accessibility:	N/A			
Installation:	Sprayed coating			
Approx extent (m ² unless stated)	N/A			
Asbestos Type:	NAD			
Condition:	N/A	Surface Treatment:	N/A

Material Risk Assessment	0	Priority Risk Assessment (PA)	N/A	Total Risk	
Recommendation:	None				
Comments:	Right elbow near stairs

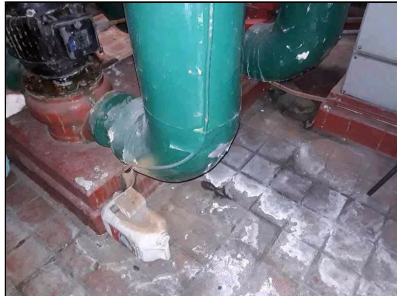
Location:		Demolition Survey - 10.03.20. to 16.03.20 - Ground floor - A - 012 - Plant room - Lagging to green pipe (the branch that runs to rear of boilers)low level elbow

Item No:	000085	Laboratory sample no:	FB004078	
Accessibility:		N/A		
Installation:		Insulation		
Approx extent (m ² unless stated)		N/A		
Asbestos Type:		NAD		
Condition:	N/A	Surface Treatment:	N/A

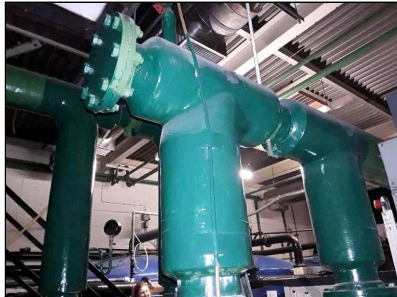
Location:		Demolition Survey - 10.03.20. to 16.03.20 - Ground floor - A - 012 - Plant room - Lagging to green pipe

Item No:	000086	Laboratory sample no:	FB004079	
Accessibility:		N/A		
Installation:		Insulation		
Approx extent (m ² unless stated)		N/A		
Asbestos Type:		NAD		
Condition:	N/A	Surface Treatment:	N/A

Material Risk Assessment	0	Priority Risk Assessment (PA)	N/A	Total Risk	
Recommendation:	None				
Comments: Same branch that runs to back of boilers. Near distribution box

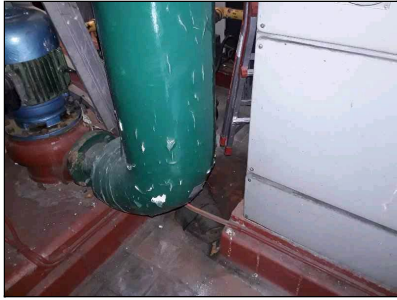
Location:	Demolition Survey - 10.03.20. to 16.03.20 - Ground floor - A - 012 - Plant room - Lagging to green pipe at elbow

Item No:	000087	Laboratory sample no:	FB004080	
Accessibility:	N/A			
Installation:	Insulation			
Approx extent (m ² unless stated)	N/A			
Asbestos Type:	NAD			
Condition:	N/A	Surface Treatment:	N/A

Material Risk Assessment	0	Priority Risk Assessment (PA)	N/A	Total Risk	
Recommendation:	None				
Comments: Near distribution box

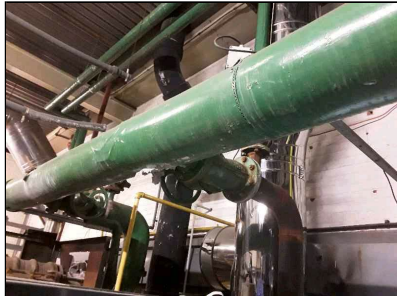
Location:	Demolition Survey - 10.03.20. to 16.03.20 - Ground floor - A - 012 - Plant room - Lagging to green pipe run as it travels across the top of the boilers

Item No:	000089	Laboratory sample no:	FB004082	
Accessibility:	N/A			
Installation:	Insulation			
Approx extent (m ² unless stated)	N/A			
Asbestos Type:	NAD			
Condition:	N/A	Surface Treatment:	N/A

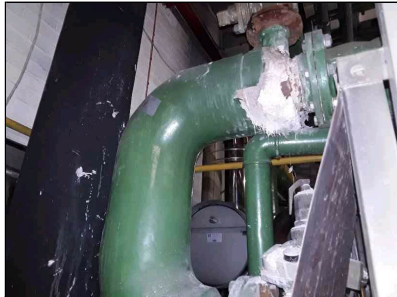
Location:	Demolition Survey - 10.03.20. to 16.03.20 - Ground floor - A - 012 - Plant room - Lagging to green pipe elbow (at rear of boilers)

Item No:	000090	Laboratory sample no:	FB004083	
Accessibility:	N/A			
Installation:	Insulation			
Approx extent (m ² unless stated)	N/A			
Asbestos Type:	NAD			
Condition:	N/A	Surface Treatment:	N/A

Material Risk Assessment	0	Priority Risk Assessment (PA)	N/A	Total Risk	
Recommendation:	None				
Comments:	Damage and debris in this area

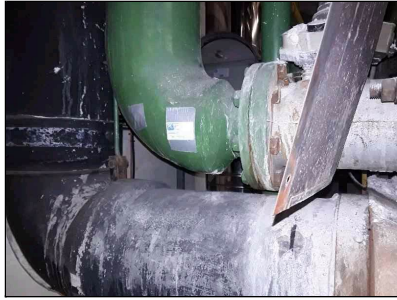
Location:		Demolition Survey - 10.03.20. to 16.03.20 - Ground floor - A - 012 - Plant room - Lagging to lower elbow at rear of boiler

Item No:	000091	Laboratory sample no:	FB004084	
Accessibility:	N/A			
Installation:	Insulation			
Approx extent (m ² unless stated)	N/A			
Asbestos Type:	NAD			
Condition:	N/A	Surface Treatment:	N/A

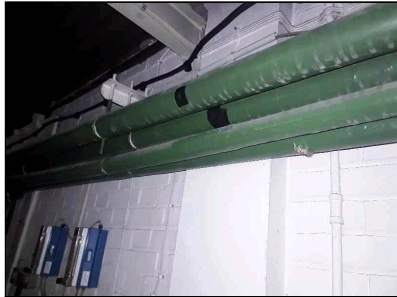
Location:		Demolition Survey - 10.03.20. to 16.03.20 - Ground floor - A - 012 - Plant room - Lagging to rear small bore green pipe at high level above gantry

Item No:	000093	Laboratory sample no:	FB004086	
Accessibility:	N/A			
Installation:	Insulation			
Approx extent (m ² unless stated)	N/A			
Asbestos Type:	NAD			
Condition:	N/A	Surface Treatment:	N/A

Material Risk Assessment	0	Priority Risk Assessment (PA)	N/A	Total Risk	
Recommendation:	None				
Comments: Negative sampling - appeared to be more like calcium insulation and was sampled where accessible. However sampled in several places .

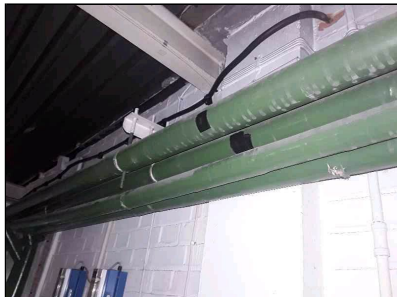
Location:		Demolition Survey - 10.03.20. to 16.03.20 - Ground floor - A - 012 - Plant room - Lagging to front small bore green pipe at high level above gantry

Item No:	000094	Laboratory sample no:	FB004087	
Accessibility:	N/A			
Installation:	Insulation			
Approx extent (m ² unless stated)	N/A			
Asbestos Type:	NAD			
Condition:	N/A	Surface Treatment:	N/A

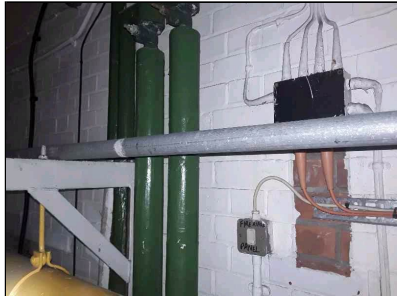
Location:	Demolition Survey - 10.03.20. to 16.03.20 - Ground floor - A - 012 - Plant room - Lagging to rear small bore green pipe running vertically down wall near gantry

Item No:	000095	Laboratory sample no:	FB004088	
Accessibility:	N/A			
Installation:	Insulation			
Approx extent (m ² unless stated)	N/A			
Asbestos Type:	NAD			
Condition:	N/A	Surface Treatment:	N/A

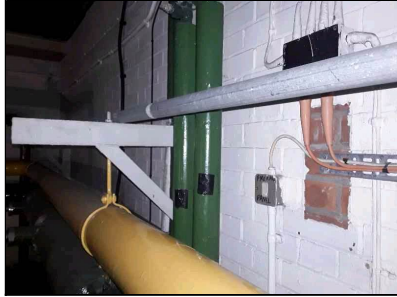
Location:	Demolition Survey - 10.03.20. to 16.03.20 - Ground floor - A - 012 - Plant room - Lagging to front small bore green pipe that runs vertically down wall near gantry

Item No:	000096	Laboratory sample no:	FB004089	
Accessibility:	N/A			
Installation:	Insulation			
Approx extent (m ² unless stated)	N/A			
Asbestos Type:	NAD			
Condition:	N/A	Surface Treatment:	N/A

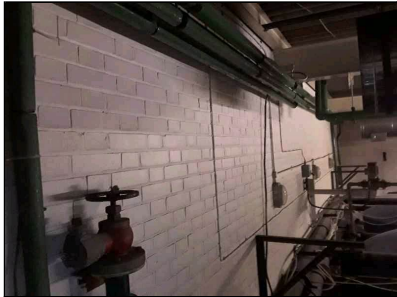
Location:	Demolition Survey - 10.03.20. to 16.03.20 - Ground floor - A - 012 - Plant room - Lagging to rear small bore green pipe running at high level above blue water tanks

Item No:	000097	Laboratory sample no:	FB004090	
Accessibility:	N/A			
Installation:	Insulation			
Approx extent (m ² unless stated)	N/A			
Asbestos Type:	NAD			
Condition:	N/A	Surface Treatment:	N/A

Material Risk Assessment	0	Priority Risk Assessment (PA)	N/A	Total Risk	
Recommendation:	None				
Comments: NOTE - This was only accessible from the gantry . It continues its run but above the tanks but unable to access or sample further.

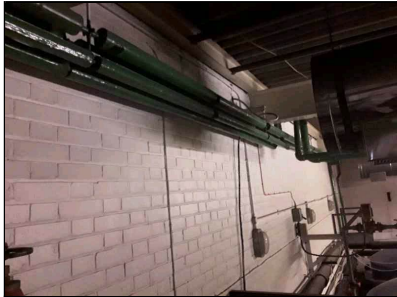
Location:	Demolition Survey - 10.03.20. to 16.03.20 - Ground floor - A - 012 - Plant room - Lagging to front small bore green pipe that runs along wall at high level above blue cylinders

Item No:	000098	Laboratory sample no:	FB004091	
Accessibility:	N/A			
Installation:	Insulation			
Approx extent (m ² unless stated)	N/A			
Asbestos Type:	NAD			
Condition:	N/A	Surface Treatment:	N/A

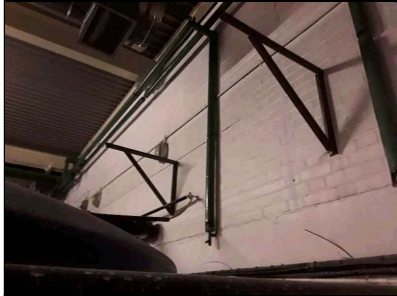
Location:	Demolition Survey - 10.03.20. to 16.03.20 - Ground floor - A - 012 - Plant room - Lagging to front small bore green pipe where it continues its run vertically down the wall to the far side of the blue water tanks

Item No:	000099	Laboratory sample no:	FB004092	
Accessibility:	N/A			
Installation:	Insulation			
Approx extent (m ² unless stated)	N/A			
Asbestos Type:	NAD			
Condition:	N/A	Surface Treatment:	N/A

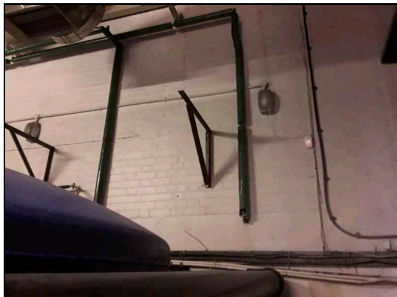
Location:	Demolition Survey - 10.03.20. to 16.03.20 - Ground floor - A - 012 - Plant room - Lagging to rear small bore green pipe as it continues its run down vertically down the wall to the far side of the blue water tanks

Item No:	000100	Laboratory sample no:	FB004093	
Accessibility:	N/A			
Installation:	Insulation			
Approx extent (m ² unless stated)	N/A			
Asbestos Type:	NAD			
Condition:	N/A	Surface Treatment:	N/A

Material Risk Assessment	0	Priority Risk Assessment (PA)	N/A	Total Risk	
Recommendation:	None				
Comments:

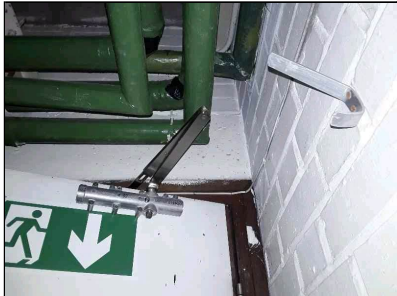
Location:		Demolition Survey - 10.03.20. to 16.03.20 - Ground floor - A - 012 - Plant room - Lagging to elbow of front small bore green pipe where it runs above gantry door

Item No:	000101	Laboratory sample no:	FB004094	
Accessibility:		N/A		
Installation:		Insulation		
Approx extent (m ² unless stated)		N/A		
Asbestos Type:		NAD		
Condition:		N/A	Surface Treatment:

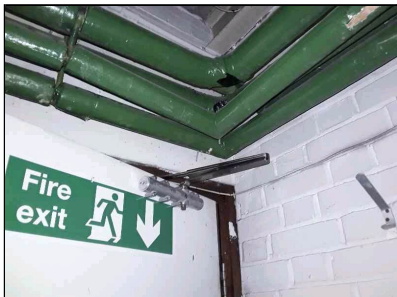
Location:		Demolition Survey - 10.03.20. to 16.03.20 - Ground floor - A - 012 - Plant room - Lagging to elbow of rear small bore green pipe where it runs above gantry door

Item No:	000102	Laboratory sample no:	FB004095	
Accessibility:		N/A		
Installation:		Insulation		
Approx extent (m ² unless stated)		N/A		
Asbestos Type:		NAD		
Condition:		N/A	Surface Treatment:

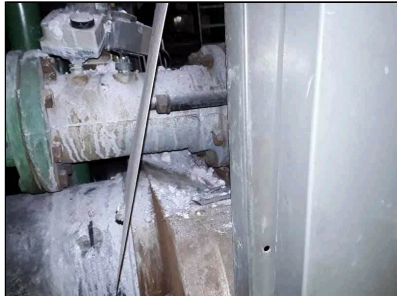
Location:		Demolition Survey - 10.03.20. to 16.03.20 - Ground floor - A - 012 - Plant room - Lagging debris to the top of and to floor near central boiler

Item No:	000103	Laboratory sample no:	FB004096	
Accessibility:	N/A			
Installation:	Debris			
Approx extent (m ² unless stated)	N/A			
Asbestos Type:	NAD			
Condition:	N/A	Surface Treatment:	N/A

Material Risk Assessment	0	Priority Risk Assessment (PA)	N/A	Total Risk	
Recommendation:	None				
Comments: Probably from damaged pipe above boiler

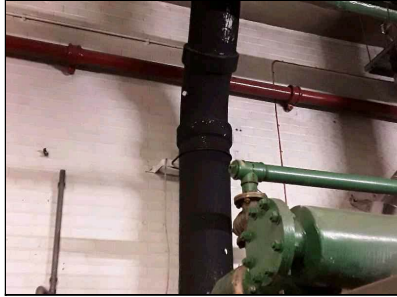
Location:		Demolition Survey - 10.03.20. to 16.03.20 - Ground floor - A - 012 - Plant room - Grey cement flue running off the central orange discount boiler

Item No:	000104	Laboratory sample no:	FB004097	
Accessibility:	Moderate			
Installation:	Cement (1)			
Approx extent (m ² unless stated)	51m			
Asbestos Type:	Chrysotile (1)			
Condition:	Low damage (1)	Surface Treatment:	Surface sealed (1)

Material Risk Assessment	4	Priority Risk Assessment (PA)	N/A	Total Risk	N/A
Recommendation:	Remove				
Comments:

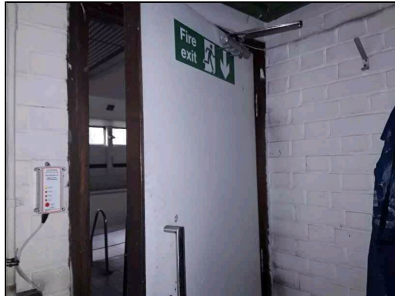
Location:		Demolition Survey - 10.03.20. to 16.03.20 - Ground floor - A - 012 - Plant room - Boarding within fire door (2 panels spliced within)

Item No:	000105	Laboratory sample no:	FB004098	
Accessibility:	Moderate			
Installation:	Boarding (2)			
Approx extent (m ² unless stated)	3			
Asbestos Type:	Chrysotile (1)			
Condition:	Low damage (1)	Surface Treatment:	Unsealed AIB/encapsulated lagging (2)

Material Risk Assessment	6	Priority Risk Assessment (PA)	N/A	Total Risk	N/A
Recommendation:	Remove				
Comments:

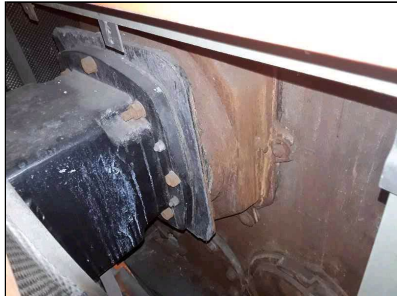
Location:		Demolition Survey - 10.03.20. to 16.03.20 - Ground floor - A - 012 - Plant room - Gaskets to the valve at the front of the viscount boiler

Item No:	000109	Laboratory sample no:	FB004102	
Accessibility:		Easy		
Installation:		Gasket(s) (2)		
Approx extent (m ² unless stated)		2no.		
Asbestos Type:		Chrysotile (1)		
Condition:		Low damage (1)	Surface Treatment: Surface sealed (1)

Material Risk Assessment	5	Priority Risk Assessment (PA)	N/A	Total Risk	N/A
Recommendation:		Remove			
Comments:

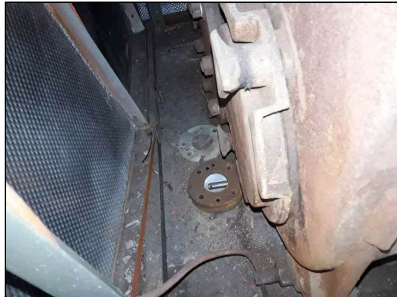
Location:		Demolition Survey - 10.03.20. to 16.03.20 - Ground floor - A - 012 - Plant room - Gasket to the floor at front of the Discount boiler

Item No:	000110	Laboratory sample no:	FB004103	
Accessibility:		Easy		
Installation:		Gasket(s) (2)		
Approx extent (m ² unless stated)		1no.		
Asbestos Type:		Chrysotile (1)		
Condition:		Low damage (1)	Surface Treatment: Surface sealed (1)

Material Risk Assessment	5	Priority Risk Assessment (PA)	N/A	Total Risk	N/A
Recommendation:		Remove			
Comments:

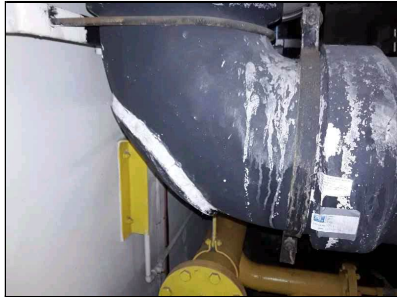
Location:	Demolition Survey - 10.03.20. to 16.03.20 - Ground floor - A - 012 - Plant room - White mastic to the boiler furnace and to the cement flu that comes off the Viscount boiler

Item No:	000111	Laboratory sample no:	FB004104	
Accessibility:	Easy			
Installation:	Mastic (1)			
Approx extent (m ² unless stated)	10lm			
Asbestos Type:	Chrysotile (1)			
Condition:	Low damage (1)	Surface Treatment:	Completely sealed (0)

Material Risk Assessment	3	Priority Risk Assessment (PA)	N/A	Total Risk	N/A
Recommendation:	Remove				
Comments:

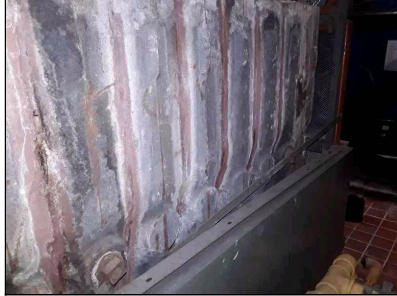
Location:	Demolition Survey - 10.03.20. to 16.03.20 - Ground floor - A - 012 - Plant room - Brown mastic to the furnace of the Viscount boiler

Item No:	000112	Laboratory sample no:	FB004105	
Accessibility:	N/A			
Installation:	Mastic			
Approx extent (m ² unless stated)	N/A			
Asbestos Type:	NAD			
Condition:	N/A	Surface Treatment:	N/A

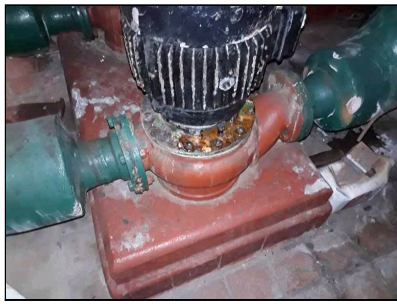
Location:		Demolition Survey - 10.03.20. to 16.03.20 - Ground floor - A - 012 - Plant room - Gaskets to the green painted valves

Item No:	000114	Laboratory sample no:	FB004107	
Accessibility:		N/A		
Installation:		Gasket(s)		
Approx extent (m ² unless stated)		N/A		
Asbestos Type:		NAD		
Condition:		N/A	Surface Treatment:	N/A

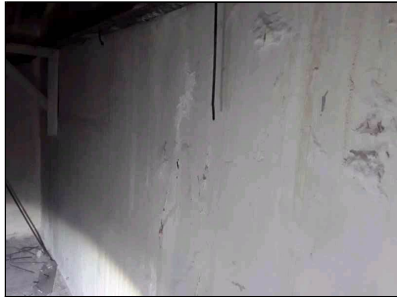
Location:	Demolition Survey - 10.03.20. to 16.03.20 - Ground floor - A - 012 - Plant room - Insulation residues to the wall that runs adjacent to gantry/stairs

Item No:	000115	Laboratory sample no:	FB004108	
Accessibility:	N/A			
Installation:	Residual insulation			
Approx extent (m ² unless stated)	N/A			
Asbestos Type:	NAD			
Condition:	N/A	Surface Treatment:	N/A

Material Risk Assessment	0	Priority Risk Assessment (PA)	N/A	Total Risk	
Recommendation:	None				
Comments: Small amounts throughout the lower sections of that wall

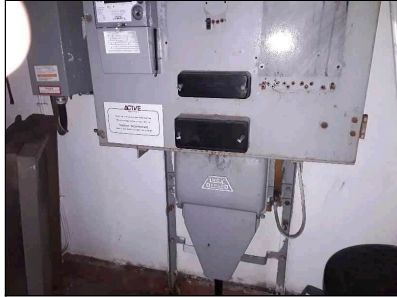
Location:	Demolition Survey - 10.03.20. to 16.03.20 - Ground floor - A - 012 - Plant room - Presumed asbestos bitumen textile wrap to incoming electrical intake cable

Item No:	000116	Laboratory sample no:	Not sampled (Presumed)	
Accessibility:	Easy			
Installation:	Textile (2)			
Approx extent (m ² unless stated)	11m			
Asbestos Type:	Crocidolite (or unknown) (3)			
Condition:	Low damage (1)	Surface Treatment:	Surface sealed (1)

Material Risk Assessment	7	Priority Risk Assessment (PA)	N/A	Total Risk	N/A
Recommendation:	Remove				
Comments: No access within any of the live distribution boxes etc in the plant room

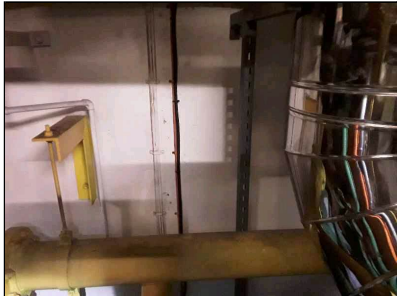
Location:		Demolition Survey - 10.03.20. to 16.03.20 - Ground floor - A - 012 - Plant room - Insulation residues to the wall behind the boilers

Item No:	000117	Laboratory sample no:	FB004109	
Accessibility:	N/A			
Installation:	Residual insulation			
Approx extent (m ² unless stated)	N/A			
Asbestos Type:	NAD			
Condition:	N/A	Surface Treatment:	N/A

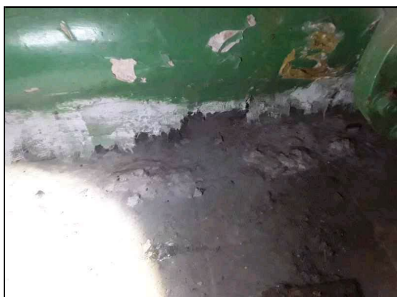
Location:		Demolition Survey - 10.03.20. to 16.03.20 - Ground floor - A - 012 - Plant room - Insulation debris to the floor below the green pipes behind the boiler

Item No:	000118	Laboratory sample no:	FB004110	
Accessibility:	N/A			
Installation:	Debris			
Approx extent (m ² unless stated)	N/A			
Asbestos Type:	NAD			
Condition:	N/A	Surface Treatment:	N/A

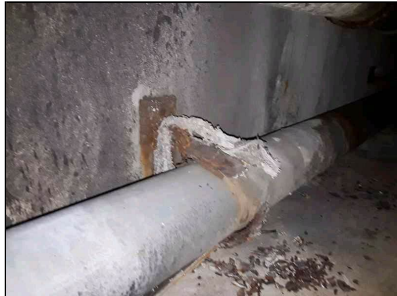
Location:		Demolition Survey - 10.03.20. to 16.03.20 - Basement - A - 025 - Plant room - below pools - Textiles to several of the pipe hangers to the left wall behind pool

Item No:	000119	Laboratory sample no:	FB004111	
Accessibility:	N/A			
Installation:	Rope			
Approx extent (m ² unless stated)	N/A			
Asbestos Type:	NAD			
Condition:	N/A	Surface Treatment:	N/A

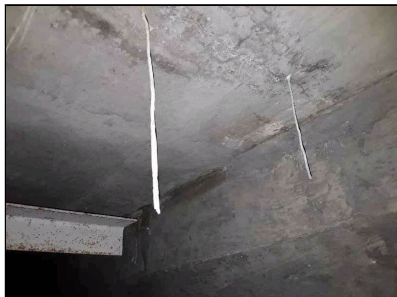
Location:		Demolition Survey - 10.03.20. to 16.03.20 - Basement - A - 025 - Plant room - below pools - Insulation to ceiling and to the pipes that run close to the ceiling

Item No:	000120	Laboratory sample no:	FB004112	
Accessibility:	N/A			
Installation:	Insulation			
Approx extent (m ² unless stated)	N/A			
Asbestos Type:	NAD			
Condition:	N/A	Surface Treatment:	N/A

Material Risk Assessment	0	Priority Risk Assessment (PA)	N/A	Total Risk	
Recommendation:	None				
Comments:	In stalactite form (negative sampling - just caused by pool chemicals)

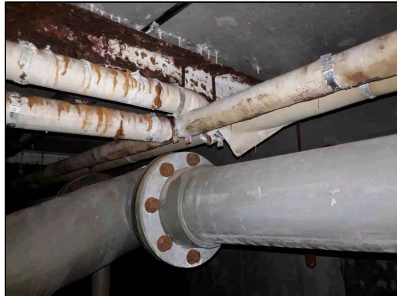
Location:		Demolition Survey - 10.03.20. to 16.03.20 - Basement - A - 025 - Plant room - below pools - Insulation to the small bore lined wrapped pipes that run around the pool

Item No:	000121	Laboratory sample no:	FB004113	
Accessibility:	N/A			
Installation:	Insulation			
Approx extent (m ² unless stated)	N/A			
Asbestos Type:	NAD			
Condition:	N/A	Surface Treatment:	N/A

Material Risk Assessment	0	Priority Risk Assessment (PA)	N/A	Total Risk	
Recommendation:	None				
Comments: Negative sampling - modern

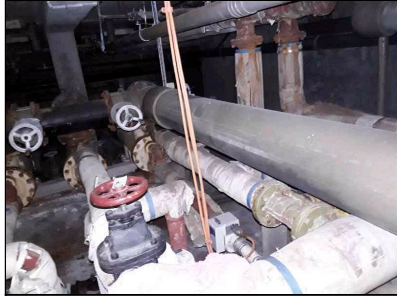
Location:		Demolition Survey - 10.03.20. to 16.03.20 - Basement - A - 025 - Plant room - below pools - Gaskets to the green valves that run off the metal pipes to the pool

Item No:	000122	Laboratory sample no:	FB004114	
Accessibility:	Easy			
Installation:	Gasket(s) (2)			
Approx extent (m ² unless stated)	Numerous			
Asbestos Type:	Chrysotile (1)			
Condition:	Low damage (1)	Surface Treatment:	Surface sealed (1)

Material Risk Assessment	5	Priority Risk Assessment (PA)	N/A	Total Risk	N/A
Recommendation:	Remove				
Comments:

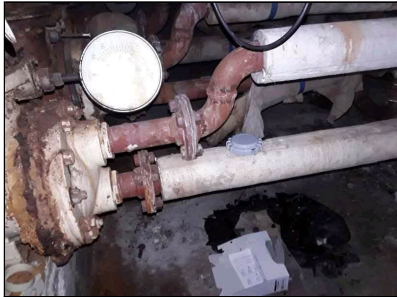
Location:		Demolition Survey - 10.03.20. to 16.03.20 - Basement - A - 025 - Plant room - below pools - Gaskets to valves on the red pipework

Item No:	000123	Laboratory sample no:	FB004115	
Accessibility:	Easy			
Installation:	Gasket(s) (2)			
Approx extent (m ² unless stated)	Throughout			
Asbestos Type:	Chrysotile (1)			
Condition:	Low damage (1)	Surface Treatment:	Surface sealed (1)

Material Risk Assessment	5	Priority Risk Assessment (PA)	N/A	Total Risk	N/A
Recommendation:	Remove				
Comments:

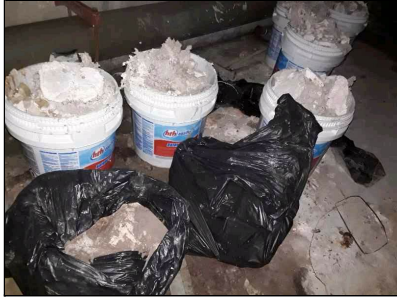
Location:		Demolition Survey - 10.03.20. to 16.03.20 - Basement - A - 025 - Plant room - below pools - Discarded insulation debris in buckets, bags and to the adjacent concrete floor

Item No:	000124	Laboratory sample no:	FB004116	
Accessibility:	N/A			
Installation:	Debris			
Approx extent (m ² unless stated)	N/A			
Asbestos Type:	NAD			
Condition:	N/A	Surface Treatment:	N/A

Material Risk Assessment	0	Priority Risk Assessment (PA)	N/A	Total Risk	
Recommendation:	None				
Comments:	Negative sampling

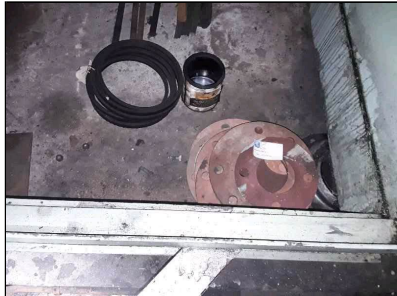
Location:		Demolition Survey - 10.03.20. to 16.03.20 - First floor - A - 024 - Plant Room - Discarded large gaskets to the floor of the concrete plinth

Item No:	000125	Laboratory sample no:	FB004117	
Accessibility:	Easy			
Installation:	Gasket(s) (2)			
Approx extent (m ² unless stated)	9no.			
Asbestos Type:	Chrysotile (1)			
Condition:	Low damage (1)	Surface Treatment:	Surface sealed (1)

Material Risk Assessment	5	Priority Risk Assessment (PA)	N/A	Total Risk	N/A
Recommendation:	Remove				
Comments:

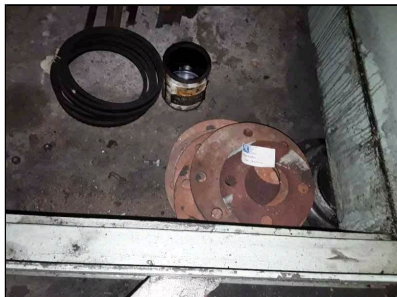
Location:		Demolition Survey - 10.03.20. to 16.03.20 - First floor - A - 024 - Plant Room - Discarded small gaskets to the floor of the concrete plinth

Item No:	000126	Laboratory sample no:	FB004118	
Accessibility:	Easy			
Installation:	Gasket(s) (2)			
Approx extent (m ² unless stated)	3no.			
Asbestos Type:	Chrysotile (1)			
Condition:	Low damage (1)	Surface Treatment:	Surface sealed (1)

Material Risk Assessment	5	Priority Risk Assessment (PA)	N/A	Total Risk	N/A
Recommendation:	Remove				
Comments:

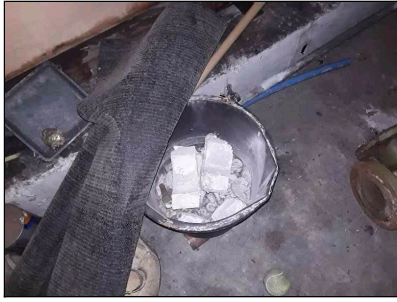
Location:	Demolition Survey - 10.03.20. to 16.03.20 - First floor - A - 024 - Plant Room - Discarded lagging within bucket to the floor

Item No:	000127	Laboratory sample no:	FB004119	
Accessibility:	N/A			
Installation:	Debris			
Approx extent (m ² unless stated)	N/A			
Asbestos Type:	NAD			
Condition:	N/A	Surface Treatment:	N/A

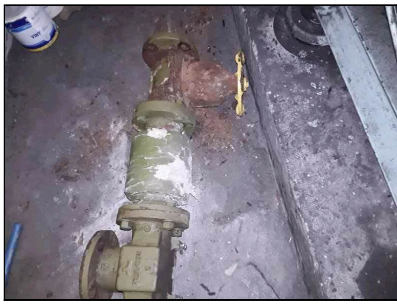
Location:	Demolition Survey - 10.03.20. to 16.03.20 - First floor - A - 024 - Plant Room - Lagging to the discarded valve to the floor

Item No:	000128	Laboratory sample no:	FB004120	
Accessibility:	N/A			
Installation:	Insulation			
Approx extent (m ² unless stated)	N/A			
Asbestos Type:	NAD			
Condition:	N/A	Surface Treatment:	N/A

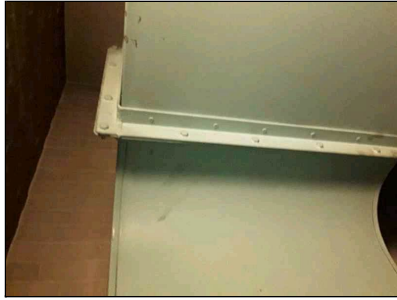
Location:		Demolition Survey - 10.03.20. to 16.03.20 - First floor - A - 024 - Plant Room - Rope to brackets of ductwork

Item No:	000129	Laboratory sample no:	SP FB004048	
Accessibility:	Easy			
Installation:	Rope (2)			
Approx extent (m ² unless stated)	Numerous			
Asbestos Type:	Chrysotile (1)			
Condition:	Low damage (1)	Surface Treatment:	Surface sealed (1)

Material Risk Assessment	5	Priority Risk Assessment (PA)	N/A	Total Risk	N/A
Recommendation:	Remove				
Comments:

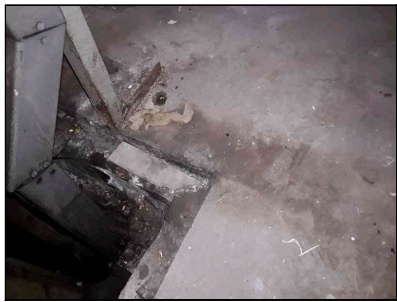
Location:		Demolition Survey - 10.03.20. to 16.03.20 - First floor - A - 024 - Plant Room - Boarding fragment to the floor near the riser

Item No:	000130	Laboratory sample no:	FB004121	
Accessibility:	Easy			
Installation:	Boarding (2)			
Approx extent (m ² unless stated)	<1			
Asbestos Type:	Amosite (2)			
Condition:	High damage (3)	Surface Treatment:	Unsealed AIB/encapsulated lagging (2)

Material Risk Assessment	9	Priority Risk Assessment (PA)	N/A	Total Risk	N/A
Recommendation:	Remove				
Comments:

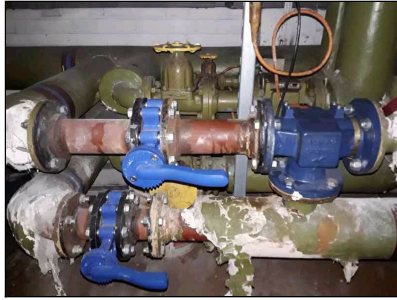
Location:		Demolition Survey - 10.03.20. to 16.03.20 - First floor - A - 024 - Plant Room - Gaskets (white) to the valves of the pipework

Item No:	000131	Laboratory sample no:	FB004122	
Accessibility:		N/A		
Installation:		Gasket(s)		
Approx extent (m ² unless stated)		N/A		
Asbestos Type:		NAD		
Condition:		N/A	Surface Treatment:

Material Risk Assessment	0	Priority Risk Assessment (PA)	N/A	Total Risk	
Recommendation:		None			
Comments:

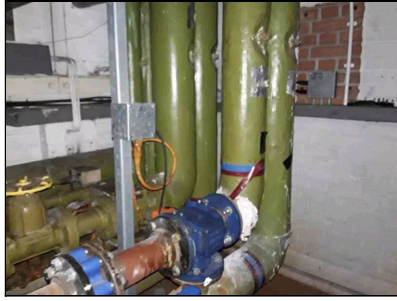
Location:		Demolition Survey - 10.03.20. to 16.03.20 - First floor - A - 024 - Plant Room - Lagging to the front left large bore pipework (near valves)

Item No:	000132	Laboratory sample no:	FB004123	
Accessibility:		N/A		
Installation:		Insulation		
Approx extent (m ² unless stated)		N/A		
Asbestos Type:		NAD		
Condition:		N/A	Surface Treatment:

Material Risk Assessment	0	Priority Risk Assessment (PA)	N/A	Total Risk	
Recommendation:		None			
Comments: Near riser . Appeared to be modern.

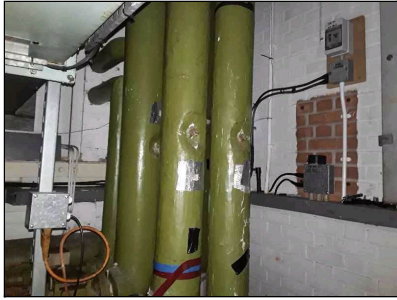
Location:		Demolition Survey - 10.03.20. to 16.03.20 - First floor - A - 024 - Plant Room - Lagging to front right large bore pipe (near valves)

Item No:	000133	Laboratory sample no:	FB004124	
Accessibility:		N/A		
Installation:		Insulation		
Approx extent (m ² unless stated)		N/A		
Asbestos Type:		NAD		
Condition:		N/A	Surface Treatment:

Material Risk Assessment	0	Priority Risk Assessment (PA)	N/A	Total Risk	
Recommendation:		None			
Comments: Appeared to be modern.

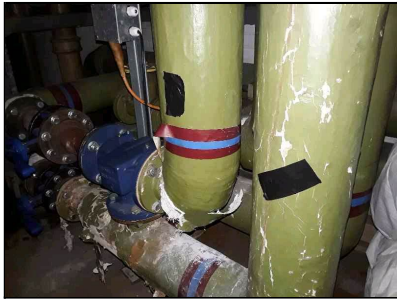
Location:		Demolition Survey - 10.03.20. to 16.03.20 - First floor - A - 024 - Plant Room - Lagging to elbow of front left large bore pipe near valves

Item No:	000134	Laboratory sample no:	FB004125	
Accessibility:		N/A		
Installation:		Insulation		
Approx extent (m ² unless stated)		N/A		
Asbestos Type:		NAD		
Condition:		N/A	Surface Treatment:

Material Risk Assessment	0	Priority Risk Assessment (PA)	N/A	Total Risk	
Recommendation:		None			
Comments:

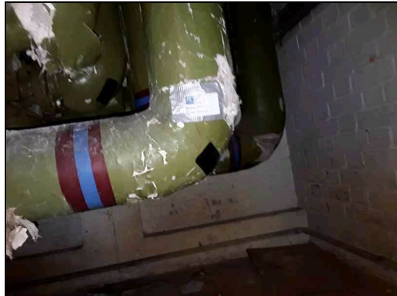
Location:	Demolition Survey - 10.03.20. to 16.03.20 - First floor - A - 024 - Plant Room - Lagging to the elbow of the front right large bore pipe near valves

Item No:	000135	Laboratory sample no:	FB004126	
Accessibility:	N/A			
Installation:	Insulation			
Approx extent (m ² unless stated)	N/A			
Asbestos Type:	NAD			
Condition:	N/A	Surface Treatment:	N/A

Material Risk Assessment	0	Priority Risk Assessment (PA)	N/A	Total Risk	
Recommendation:	None				
Comments:

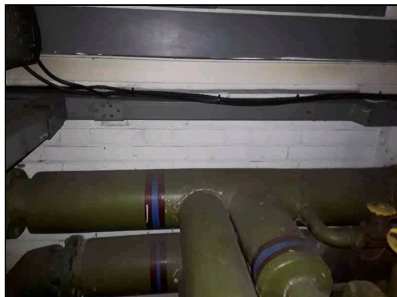
Location:	Demolition Survey - 10.03.20. to 16.03.20 - First floor - A - 024 - Plant Room - Lagging to large bore horizontal pipe (upper one) that runs to the rear of the valves

Item No:	000136	Laboratory sample no:	FB004127	
Accessibility:	N/A			
Installation:	Insulation			
Approx extent (m ² unless stated)	N/A			
Asbestos Type:	NAD			
Condition:	N/A	Surface Treatment:	N/A

Material Risk Assessment	0	Priority Risk Assessment (PA)	N/A	Total Risk	
Recommendation:	None				
Comments:	Appeared modern

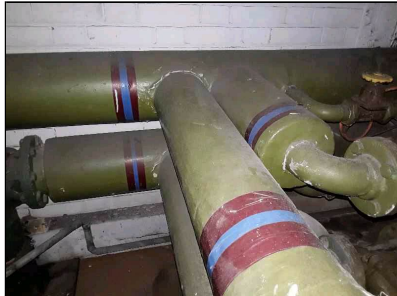
Location:		Demolition Survey - 10.03.20. to 16.03.20 - First floor - A - 024 - Plant Room - Lagging to the large bore horizontal pipe (lower one) that runs to the rear of the valves

Item No:	000137	Laboratory sample no:	FB004128	
Accessibility:	N/A			
Installation:	Insulation			
Approx extent (m ² unless stated)	N/A			
Asbestos Type:	NAD			
Condition:	N/A	Surface Treatment:	N/A

Material Risk Assessment	0	Priority Risk Assessment (PA)	N/A	Total Risk	
Recommendation:	None				
Comments: Appeared modern

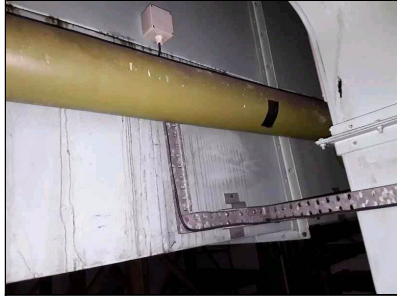
Location:		Demolition Survey - 10.03.20. to 16.03.20 - First floor - A - 024 - Plant Room - Lagging to the length of the small bore green pipe that runs horizontally to the ductwork

Item No:	000138	Laboratory sample no:	FB004129	
Accessibility:	N/A			
Installation:	Insulation			
Approx extent (m ² unless stated)	N/A			
Asbestos Type:	NAD			
Condition:	N/A	Surface Treatment:	N/A

Material Risk Assessment	0	Priority Risk Assessment (PA)	N/A	Total Risk	
Recommendation:	None				
Comments:

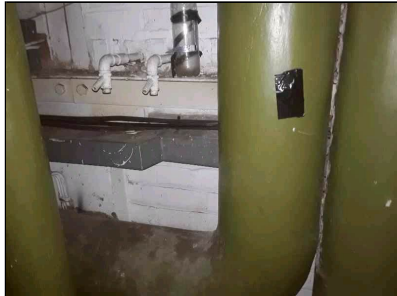
Location:		Demolition Survey - 10.03.20. to 16.03.20 - First floor - A - 024 - Plant Room - Lagging to the elbow of the upper large bore pipe (that runs horizontally behind valves)

Item No:	000139	Laboratory sample no:	FB004130	
Accessibility:	N/A			
Installation:	Insulation			
Approx extent (m ² unless stated)	N/A			
Asbestos Type:	NAD			
Condition:	N/A	Surface Treatment:	N/A

Material Risk Assessment	0	Priority Risk Assessment (PA)	N/A	Total Risk	
Recommendation:	None				
Comments:

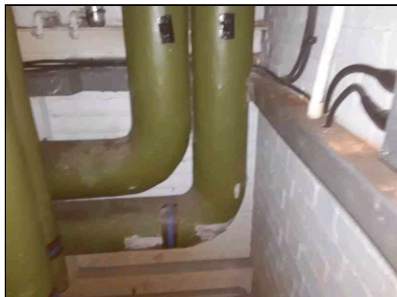
Location:		Demolition Survey - 10.03.20. to 16.03.20 - First floor - A - 024 - Plant Room - Lagging to the elbow of the large bore green pipe that runs horizontally behind valves

Item No:	000140	Laboratory sample no:	FB004131	
Accessibility:	N/A			
Installation:	Insulation			
Approx extent (m ² unless stated)	N/A			
Asbestos Type:	NAD			
Condition:	N/A	Surface Treatment:	N/A

Material Risk Assessment	0	Priority Risk Assessment (PA)	N/A	Total Risk	
Recommendation:	None				
Comments:

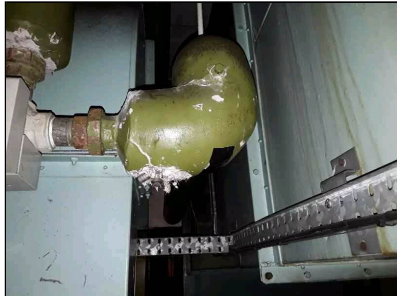
Location:		Demolition Survey - 10.03.20. to 16.03.20 - First floor - A - 024 - Plant Room - Lagging to the elbow of the small bore green pipe that runs horizontally to the ductwork

Item No:	000141	Laboratory sample no:	FB004132	
Accessibility:	N/A			
Installation:	Insulation			
Approx extent (m ² unless stated)	N/A			
Asbestos Type:	NAD			
Condition:	N/A	Surface Treatment:	N/A

Material Risk Assessment	0	Priority Risk Assessment (PA)	N/A	Total Risk	
Recommendation:	None				
Comments:

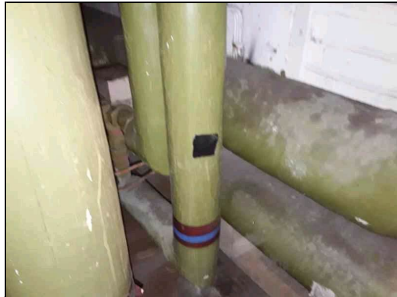
Location:		Demolition Survey - 10.03.20. to 16.03.20 - First floor - A - 024 - Plant Room - Lagging to the small bore green pipes (near valves)

Item No:	000142	Laboratory sample no:	FB004133	
Accessibility:	N/A			
Installation:	Insulation			
Approx extent (m ² unless stated)	N/A			
Asbestos Type:	NAD			
Condition:	N/A	Surface Treatment:	N/A

Material Risk Assessment	0	Priority Risk Assessment (PA)	N/A	Total Risk	
Recommendation:	None				
Comments:	All lagging within the plant room appeared to be modern.

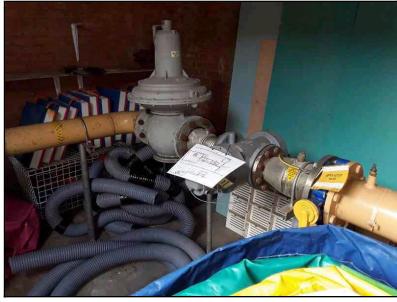
Location:		Demolition survey - RA - Externals - 16.03.20 - External - A-022 - Store - Gaskets to flanges on gas pipe

Item No:	000143	Laboratory sample no:	FA002631	
Accessibility:		N/A		
Installation:		Gasket(s)		
Approx extent (m ² unless stated)		N/A		
Asbestos Type:		NAD		
Condition:		N/A	Surface Treatment:

Material Risk Assessment	0	Priority Risk Assessment (PA)	N/A	Total Risk	
Recommendation:		None			
Comments:

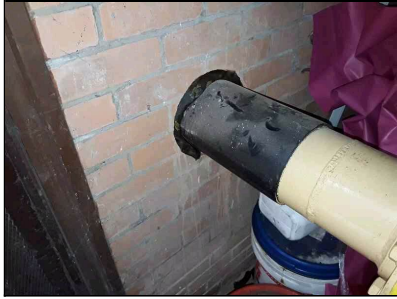
Location:		Demolition survey - RA - Externals - 16.03.20 - External - A-022 - Store - Mastic sealant to gas pipe as it extends through wall from outside

Item No:	000144	Laboratory sample no:	FA002632	
Accessibility:		N/A		
Installation:		Mastic		
Approx extent (m ² unless stated)		N/A		
Asbestos Type:		NAD		
Condition:		N/A	Surface Treatment:

Material Risk Assessment	0	Priority Risk Assessment (PA)	N/A	Total Risk	
Recommendation:		None			
Comments:

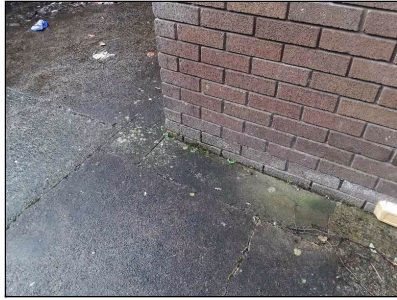
Location:		Demolition survey - RA - Externals - 16.03.20 - External - EX-001 - Perimeter wall - Bitumen damp proof course to low level brick work

Item No:	000145	Laboratory sample no:	FA002633	
Accessibility:		Moderate		
Installation:		Bitumen (1)		
Approx extent (m ² unless stated)		>100lm		
Asbestos Type:		Chrysotile (1)		
Condition:		Low damage (1)	Surface Treatment:	Completely sealed (0)

Material Risk Assessment	3	Priority Risk Assessment (PA)	N/A	Total Risk	N/A
Recommendation:	Remove				
Comments:
