DEMOLITION SURVEY
DENTON SWIMMING POOL
VICTORIA STREET
DENTON
MANCHESTER

Report prepared for:	AA Woods Holding Ltd Alma Street St Helens WA9 3AR
Report reference:	J180264
Issue date:	March 2020
Survey completed by: Karl Koffman Senior Surveyor

A Demolition Survey of Denton Swimming Pool, Victoria Street, Denton, Manchester, , M34 3GU, has been undertaken by AEC.

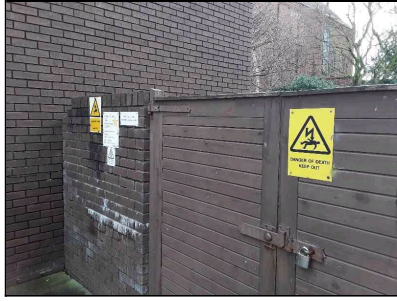
Location:		Demolition survey - RA - Externals - 16.03.20 - External - A-023 - Store (substation) - Inaccessible due to being live and the responsibility of the utility company

Item No:	000146	Laboratory sample no:	Not sampled	
Accessibility:		No access gained		
Installation:		Unknown (3)		
Approx extent (m ² unless stated)		Unknown		
Asbestos Type:		Presumed asbestos (3)		
Condition:		High damage (3)	Surface Treatment:	Unsealed (3)

Material Risk Assessment	12	Priority Risk Assessment (PA)	N/A	Total Risk	12
Recommendation:	Presume ACMs are present until area has been surveyed				
Comments:

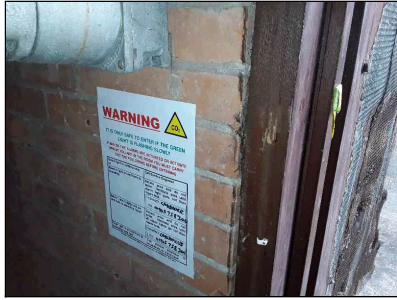
Location:		Demolition survey - RA - Externals - 16.03.20 - External - A-022 - Store - Felt packers to timber door frame

Item No:	000147	Laboratory sample no:	FA002634	
Accessibility:		Easy		
Installation:		Felt (1)		
Approx extent (m ² unless stated)		6no.		
Asbestos Type:		Chrysotile (1)		
Condition:		Low damage (1)	Surface Treatment:	Completely sealed (0)

Material Risk Assessment	3	Priority Risk Assessment (PA)	N/A	Total Risk	N/A
Recommendation:		Remove			
Comments:

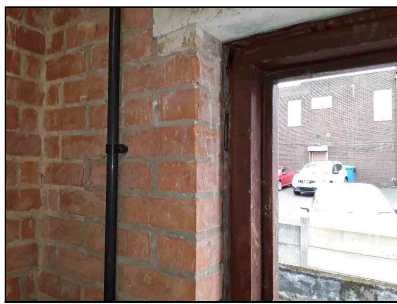
Location:		Demolition survey - RA - Externals - 16.03.20 - External - A-021 - Store - Felt packers to timber door frame

Item No:	000148	Laboratory sample no:	SP FA002634	
Accessibility:		Easy		
Installation:		Felt (1)		
Approx extent (m ² unless stated)		6no.		
Asbestos Type:		Chrysotile (1)		
Condition:		Low damage (1)	Surface Treatment:	Completely sealed (0)

Material Risk Assessment	3	Priority Risk Assessment (PA)	N/A	Total Risk	N/A
Recommendation:		Remove			
Comments:

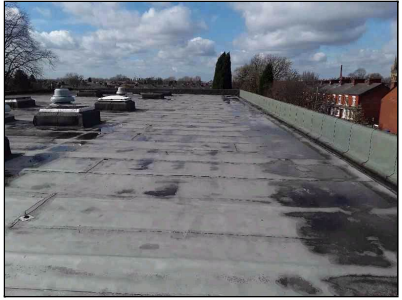
Location:		Demolition survey - RA - Externals - 16.03.20 - External - EX-002 - Upper flat roof - Roofing felt to flat roof

Item No:	000149	Laboratory sample no:	FA002635	
Accessibility:		N/A		
Installation:		Roofing felt		
Approx extent (m ² unless stated)		N/A		
Asbestos Type:		NAD		
Condition:		N/A	Surface Treatment:

Material Risk Assessment	0	Priority Risk Assessment (PA)	N/A	Total Risk	
Recommendation:	None				
Comments:

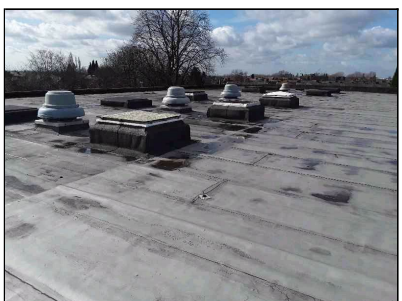
Location:		Demolition survey - RA - Externals - 16.03.20 - External - EX-002 - Upper flat roof - Roofing felt to flat roof

Item No:	000150	Laboratory sample no:	FA002636	
Accessibility:		N/A		
Installation:		Roofing felt		
Approx extent (m ² unless stated)		N/A		
Asbestos Type:		NAD		
Condition:		N/A	Surface Treatment:

Material Risk Assessment	0	Priority Risk Assessment (PA)	N/A	Total Risk	
Recommendation:	None				
Comments:

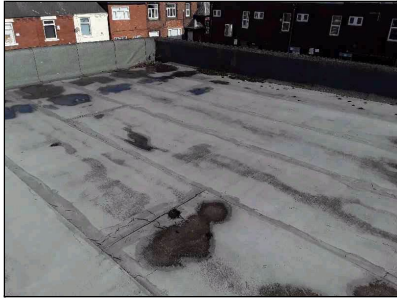
Location:		Demolition survey - RA - Externals - 16.03.20 - External - EX-002 - Upper flat roof - Roofing felt to flat roof

Item No:	000151	Laboratory sample no:	FA002637	
Accessibility:	N/A			
Installation:	Roofing felt			
Approx extent (m ² unless stated)	N/A			
Asbestos Type:	NAD			
Condition:	N/A	Surface Treatment:	N/A

Material Risk Assessment	0	Priority Risk Assessment (PA)	N/A	Total Risk	
Recommendation:	None				
Comments:

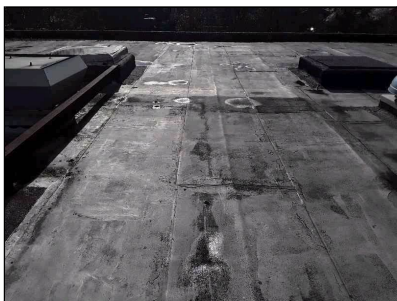
Location:		Demolition survey - RA - Externals - 16.03.20 - External - EX-002 - Upper flat roof - Roofing felt to flat roof

Item No:	000152	Laboratory sample no:	FA002638	
Accessibility:	N/A			
Installation:	Roofing felt			
Approx extent (m ² unless stated)	N/A			
Asbestos Type:	NAD			
Condition:	N/A	Surface Treatment:	N/A

Material Risk Assessment	0	Priority Risk Assessment (PA)	N/A	Total Risk	
Recommendation:	None				
Comments:

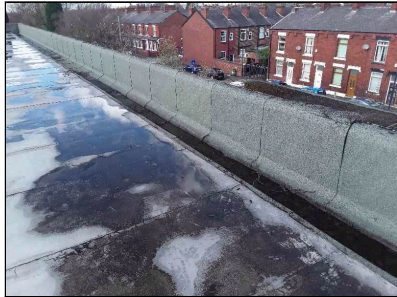
Location:		Demolition survey - RA - Externals - 16.03.20 - External - EX-002 - Upper flat roof - Boarding to roof around perimeter of upper flat beneath bitumen roof felt

Item No:	000153	Laboratory sample no:	FA002639	
Accessibility:	Difficult			
Installation:	Boarding (2)			
Approx extent (m ² unless stated)	100lm			
Asbestos Type:	Amosite (2)			
Condition:	Low damage (1)	Surface Treatment:	Surface sealed (1)

Material Risk Assessment	6	Priority Risk Assessment (PA)	N/A	Total Risk	N/A
Recommendation:	Remove				
Comments:

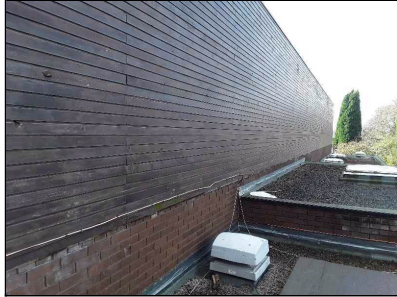
Location:		Demolition survey - RA - Externals - 16.03.20 - External - EX-003 - Lower flat roof - Bitumen paper beneath timber cladding and polystyrene insulation around upper flat roof perimeter

Item No:	000154	Laboratory sample no:	FA002640	
Accessibility:	N/A			
Installation:	Bitumen			
Approx extent (m ² unless stated)	N/A			
Asbestos Type:	NAD			
Condition:	N/A	Surface Treatment:	N/A

Material Risk Assessment	0	Priority Risk Assessment (PA)	N/A	Total Risk	
Recommendation:	None				
Comments:

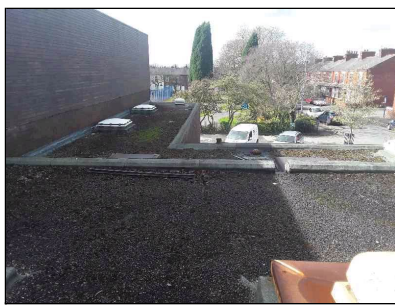
Location:		Demolition survey - RA - Externals - 16.03.20 - External - EX-003 - Lower flat roof - Roofing felt to flat roof

Item No:	000155	Laboratory sample no:	FA002641	
Accessibility:		N/A		
Installation:		Roofing felt		
Approx extent (m ² unless stated)		N/A		
Asbestos Type:		NAD		
Condition:		N/A	Surface Treatment:

Material Risk Assessment	0	Priority Risk Assessment (PA)	N/A	Total Risk	
Recommendation:		None			
Comments:

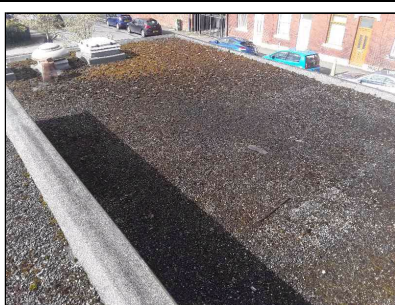
Location:		Demolition survey - RA - Externals - 16.03.20 - External - EX-003 - Lower flat roof - Roofing felt to flat roof

Item No:	000156	Laboratory sample no:	FA002642	
Accessibility:		N/A		
Installation:		Roofing felt		
Approx extent (m ² unless stated)		N/A		
Asbestos Type:		NAD		
Condition:		N/A	Surface Treatment:

Material Risk Assessment	0	Priority Risk Assessment (PA)	N/A	Total Risk	
Recommendation:		None			
Comments:

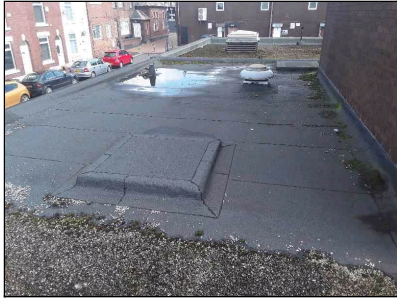
Location:		Demolition survey - RA - Externals - 16.03.20 - External - EX-003 - Lower flat roof - Roofing felt to flat roof

Item No:	000157	Laboratory sample no:	FA002643	
Accessibility:		N/A		
Installation:		Roofing felt		
Approx extent (m ² unless stated)		N/A		
Asbestos Type:		NAD		
Condition:		N/A	Surface Treatment:

Material Risk Assessment	0	Priority Risk Assessment (PA)	N/A	Total Risk	
Recommendation:	None				
Comments:

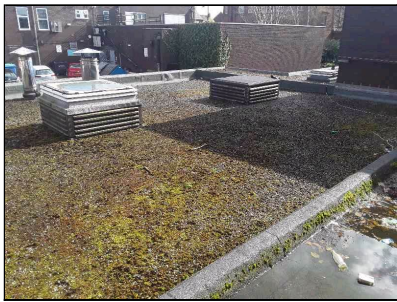
Location:		Demolition survey - RA - Externals - 16.03.20 - External - EX-003 - Lower flat roof - Roofing felt to flat roof

Item No:	000158	Laboratory sample no:	FA002644	
Accessibility:		N/A		
Installation:		Roofing felt		
Approx extent (m ² unless stated)		N/A		
Asbestos Type:		NAD		
Condition:		N/A	Surface Treatment:

Material Risk Assessment	0	Priority Risk Assessment (PA)	N/A	Total Risk	
Recommendation:	None				
Comments:

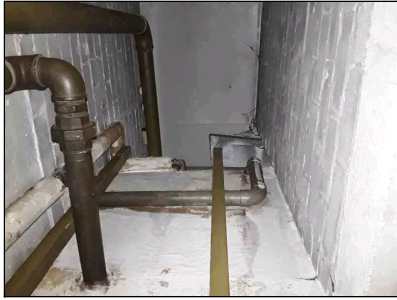
Location:		Demolition Survey - 10.03.20. to 16.03.20 - First floor - Tank Room (located above plant room A 024) - No suspect materials

Item No:	000159	Laboratory sample no:	Not sampled	
Accessibility:		N/A		
Installation:		Unknown		
Approx extent (m ² unless stated)		N/A		
Asbestos Type:		NAD		
Condition:		N/A	Surface Treatment:

Material Risk Assessment	0	Priority Risk Assessment (PA)	N/A	Total Risk	
Recommendation:		None			
Comments: Polystyrene cladding to water tank.
